123269
July 1, 2016

Board of Selectmen
Town of New London
375 Main Street
New London, NH 03257-7813

SUBJECT: Pleasant Lake Dam Alternatives Summary Report

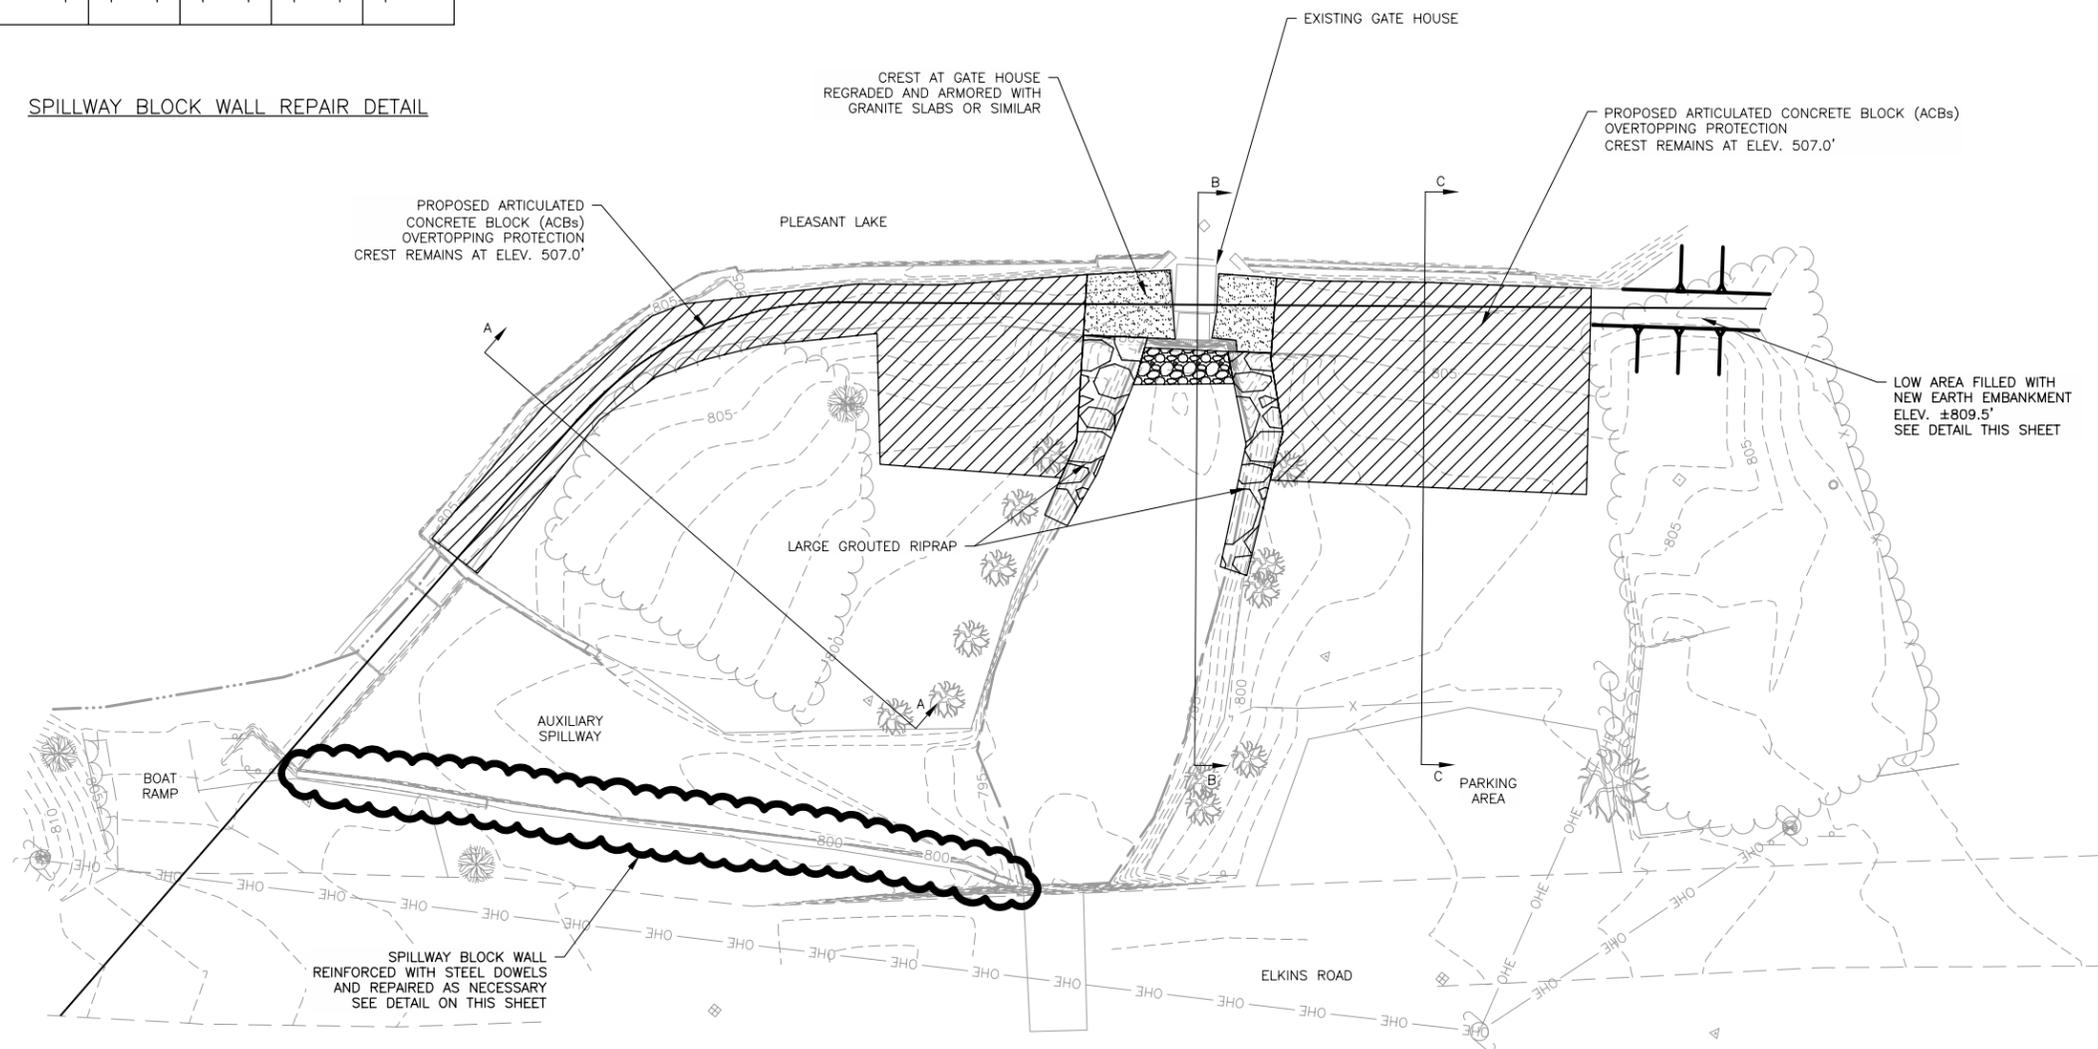
SPILLWAY BLOCK WALL REPAIR DETAIL

In general, the dam is in good condition with a few minor geometric deficiencies including a low area at the left abutment and an irregular crest shape. In addition, the block wall along the auxiliary spillway channel is exhibiting signs of deterioration and minor displacement.

- Low spot in the crest: The low area near the left abutment is a potential flow path that is not protected against erosion. All alternatives include the extension of the existing earth embankment across the low spot to create a uniform crest elevation.
- Irregular crest: All alternatives will include provisions for regrading the crest and restoring a uniform shape and elevation.
- Auxiliary spillway channel block wall: All alternatives will include a detail for structurally connecting the blocks by dowelling them together with steel bars.
