Sites 1, 1A, 1B: County Road Brook Culverts, at 3 Locations Along Columbus Avenue

Site Assessment

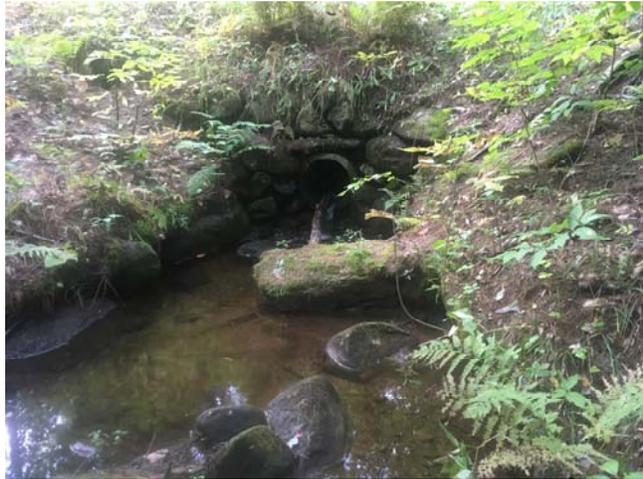
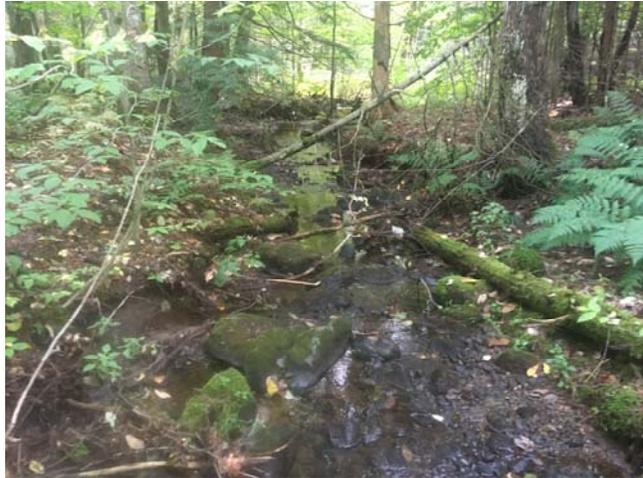
An inspection of the largest culvert at County Road Brook and Columbus Avenue (Site 1) indicated a moderate amount of historical bank erosion at the downstream end of the culvert due to the undersized pipe (Photo 1-1), however banks quickly converge back to normal bankfull widths immediately downstream (Photo 1-2). Good vegetation buffers are present along the road, and no obvious signs of road sand exist in the channel bed. Crossings at 1A and 1B are smaller pipes (~12") with minimal to no erosion issues.

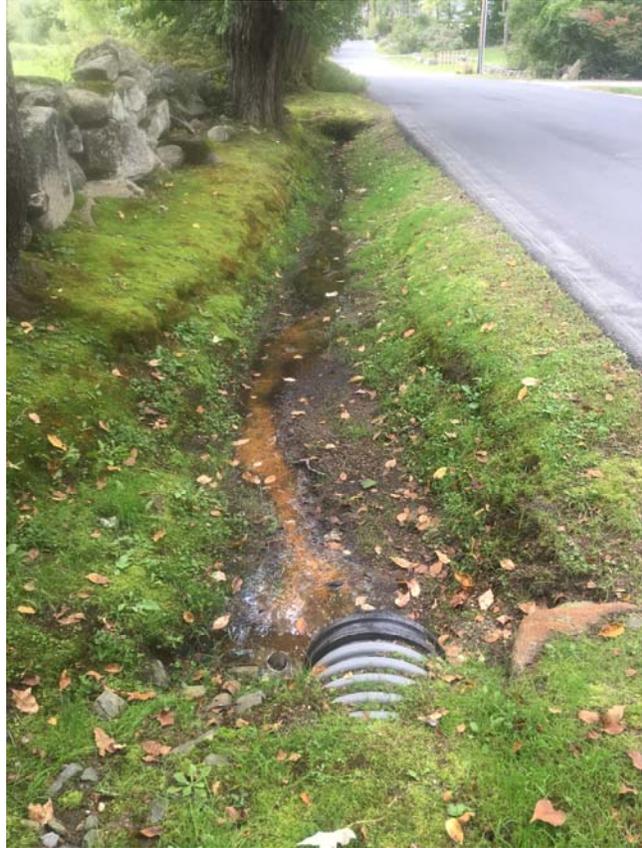
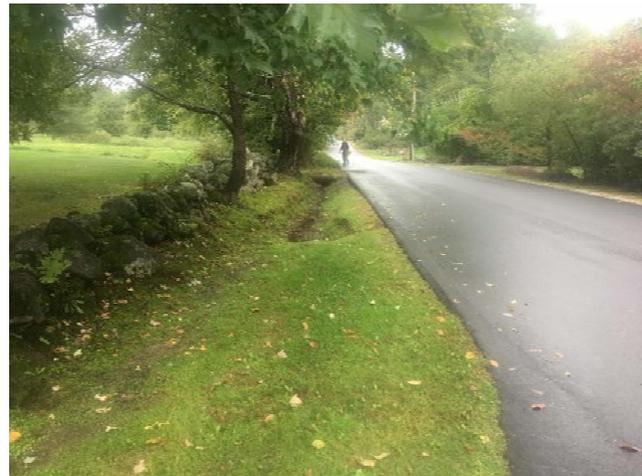
An existing swale that runs along the southwestern edge of Burpee Hill Road between Green Lane and County Road, currently accepts stormwater runoff flows from Burpee Hill Road, and conveys additional impervious flows from Knights Hill Road. The swale banks show signs of low to moderate erosion.

The swale is in fair condition but vegetation could be added to improve water quality treatment, or could be converted to a gravel wetland to improve treatment and storage of stormwater runoff.

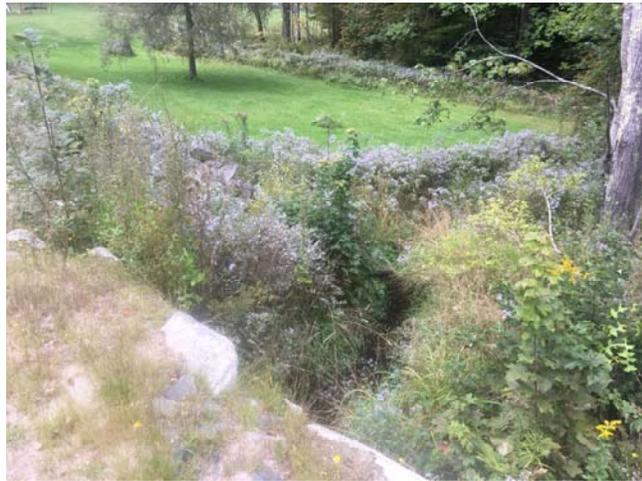
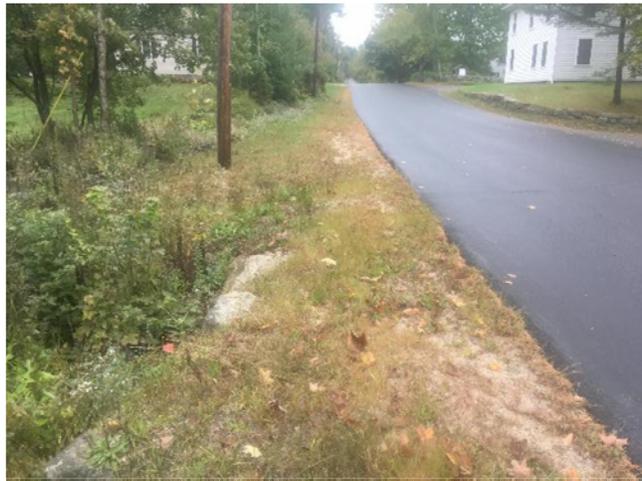
An inspection of this culvert indicated the culvert and headwalls are in good shape (Photo 5-1), but there is evidence of road runoff conveying sediment to the upstream end of the culvert, along both roadway approaches (Photo 5-2).

Install check dams along both roadway approaches, on upstream side of culvert.

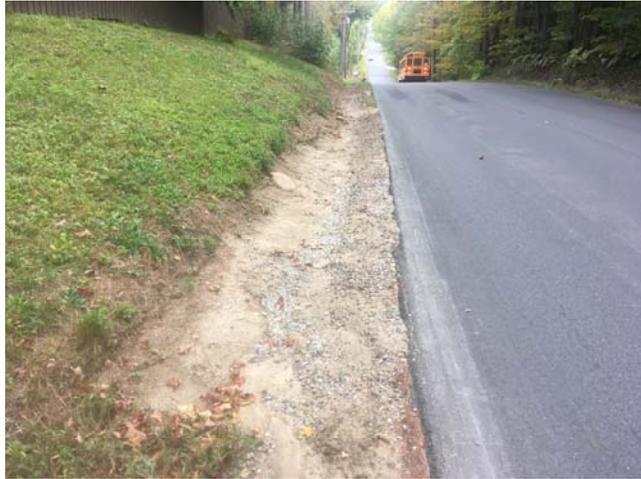
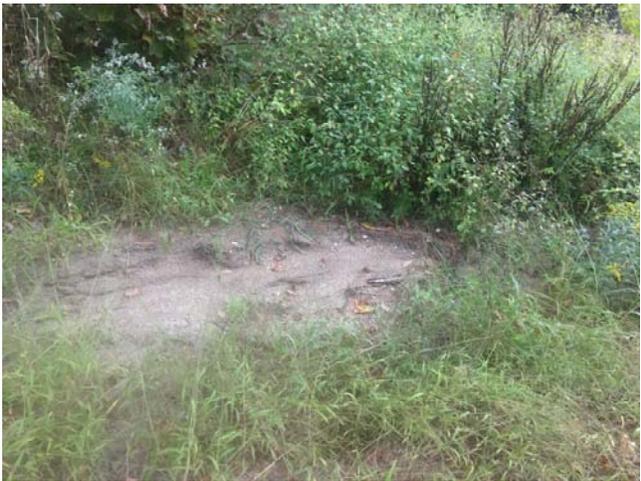
Erosion was observed along the northern road shoulder swale at the top of the hill, and heading down hill (Photo 6-1), to the east. The eroded sediment seems to settle out at the hydrant (Photo 6-2), and is expected to not reach the stream during low to moderate storm events.

Install check dams in the swale along the northern side of the road, going down hill to the east. Note that implementing suggestions for Site 5 would include implementation of these improvements as well.

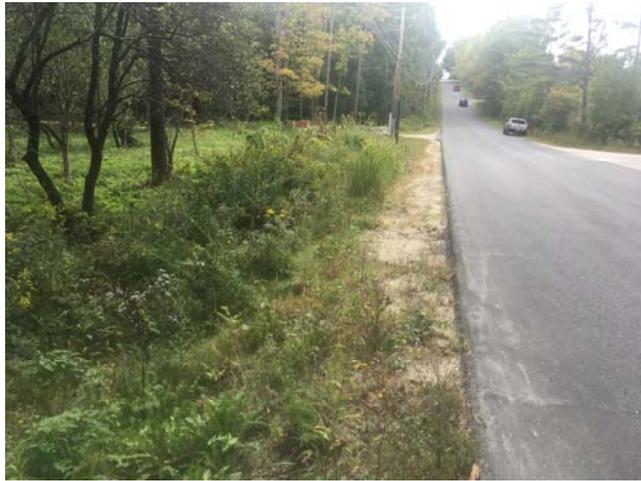
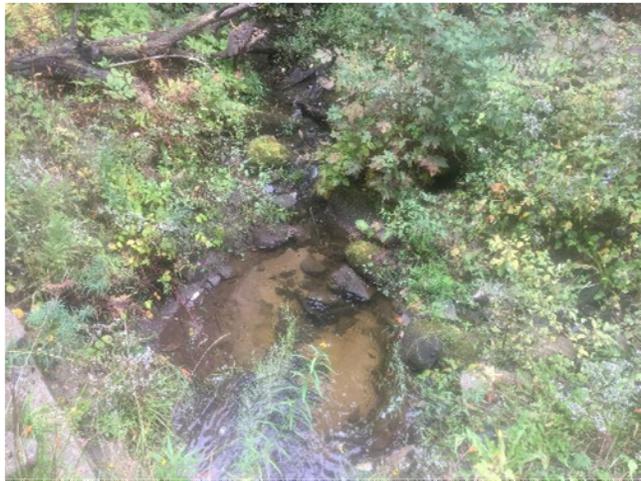
The culvert at Site 7 conveys flow from another County Road Brook tributary running north to south, under Burpee Hill Road, while 7A conveys flow from the headwaters of County Road Brook, under Pine Hill Road. While no significant erosion or water quality problems were observed at either site, there is evidence of road runoff conveying sediment to the downstream end of the culvert at Site 7, along both roadway approaches (Photo 7-1). Road sand was also observed at the downstream end of the culvert at Site 7 (Photo 7-2).

Install check dams along both roadway approaches, on the downstream side of the culvert at Site 7.

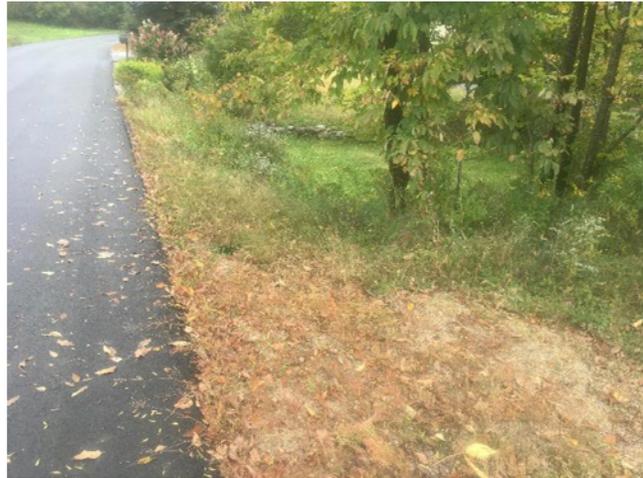
Photo 8-1

While no significant erosion or water quality problems were observed at the site, there is evidence of road runoff conveying sediment to the downstream end of the culvert on the right bank side, while looking downstream (Photo 8-1).

Install check dams along right roadway approaches on the downstream side of the culvert at Site 8.

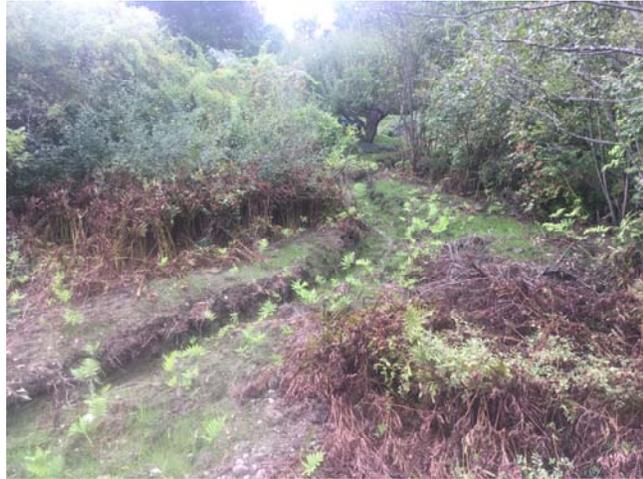
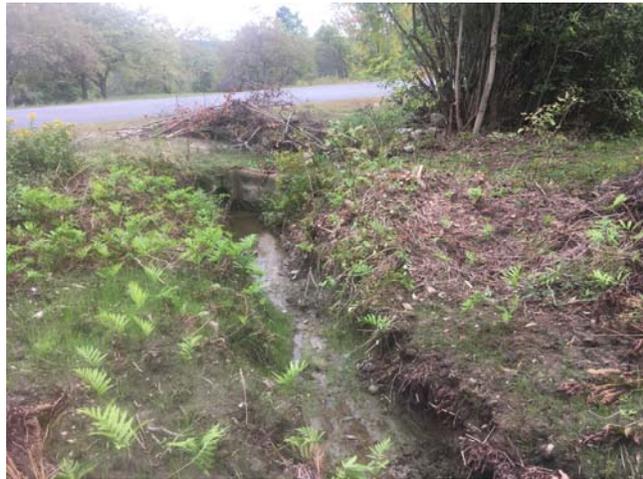
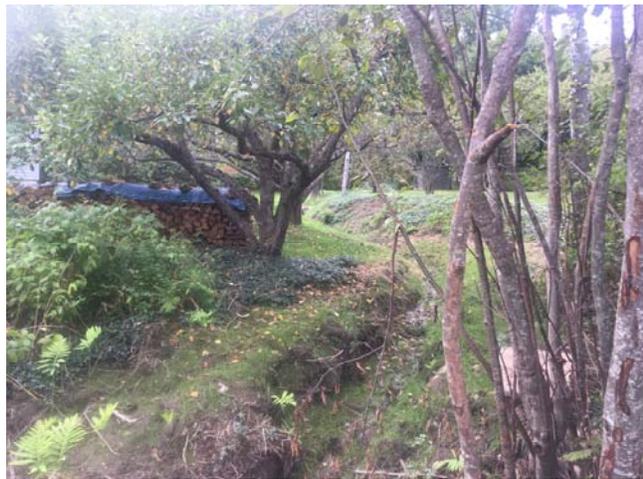
Inspection of Site 9 indicated significant manipulation of a drainage channel that runs through the backyard of a residential property (Photos 9-1 to 9-3). Evidence of vegetation removal and ditching of the channel with a small excavator or machine were observed. The channel is approximately 2-3' wide and 1-2' deep, and the bed and banks of the channel were left completely bare. There is high potential for a significant amount of sediment to be conveyed downstream during low, moderate and high storm events. Site 12 is the upstream end of this project.

At a minimum, seed the channel bed and banks and install erosion control fabric, followed by additional plantings. Reshaping of the channel to mimic a natural stream cross section is also recommended.

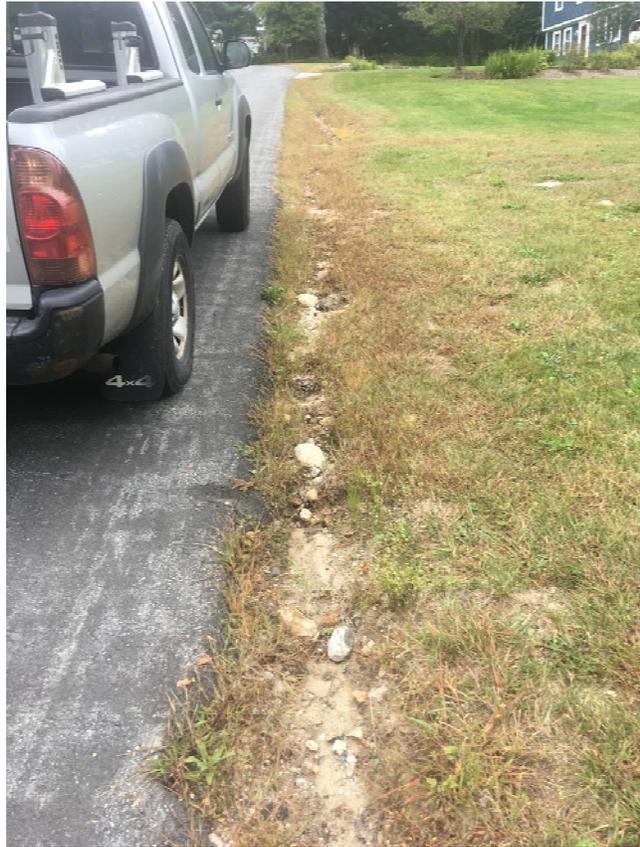
Photo 10-1

Minor shoulder erosion was observed along the northern side of the road, at the northern-most section of Gay Farm Road (Photo 10-1).

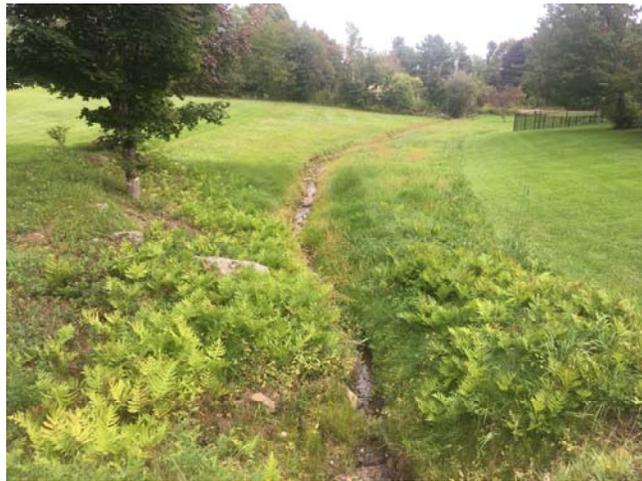
Photo 11-1

Minor erosion was observed at the culvert of another small stream tributary to County Road Brook, crossing Gay Farm Road along the western portion of the development (Photo 11-1). The stream banks quickly stabilize approximately 10' downstream of the culvert.

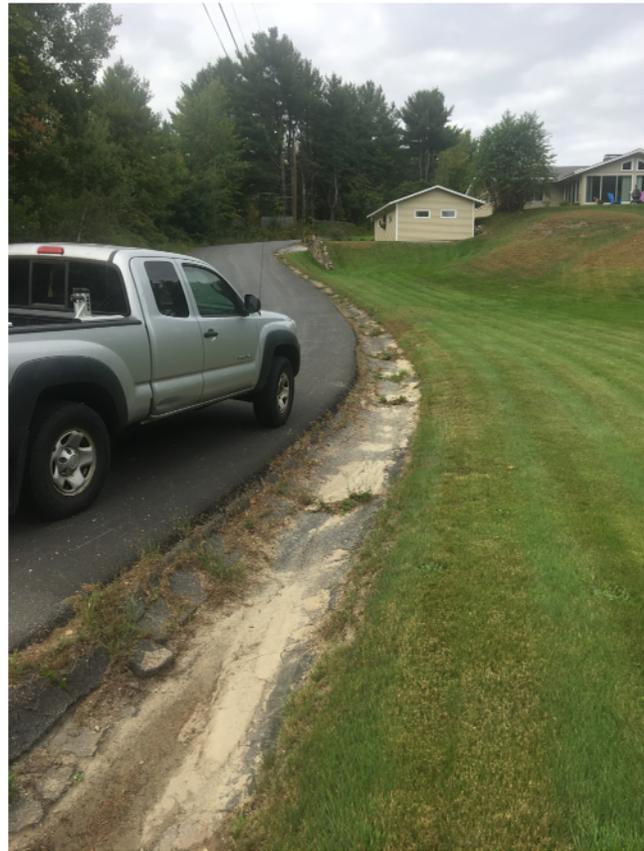
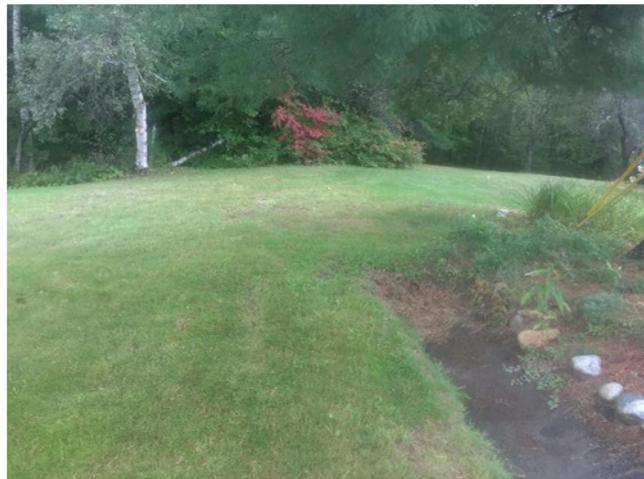
A paved swale was found along the eastern side of Farwell Lane, coming down the hill from its intersection with Burpee Hill Road (Photo 13-1). No signs of erosion were observed in the vicinity of the swale (Photo 13-2).

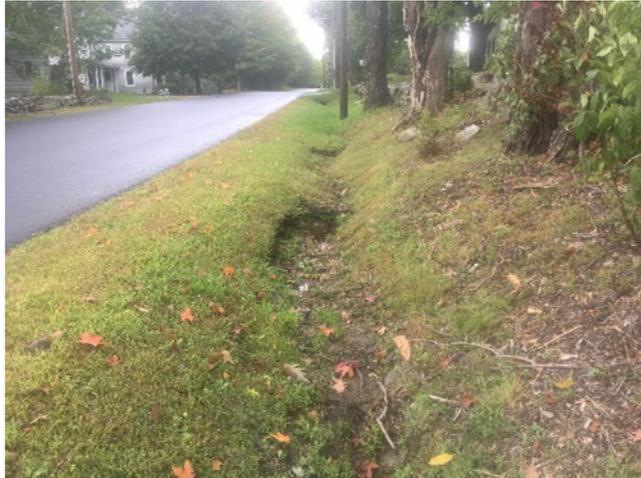
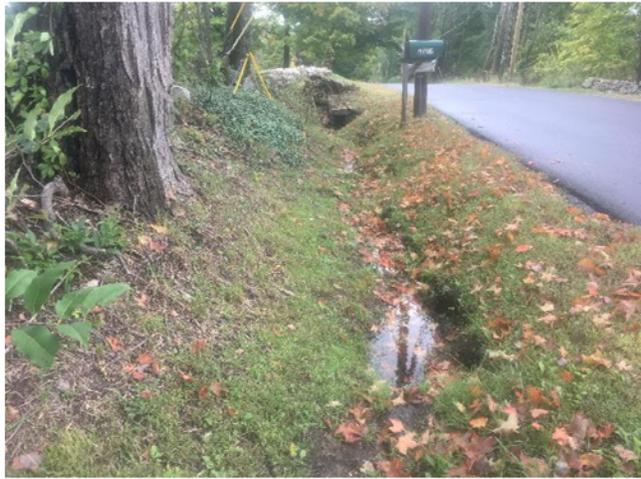
Erosion was observed along the northern road shoulder swale along Burpee Hill Road, northwest of Gay Farm Road (Photos 14-1 and 14-2).

Install check dams along the northern side of the road at 3-4 locations in the vicinity of Gay Farm Road.
