Guidelines for Tree Cutting in the Shore Land Overlay District Waterfront Buffer

Report of Tree Inspection

Don Kendall Property
111 Sunset Shores New London, NH

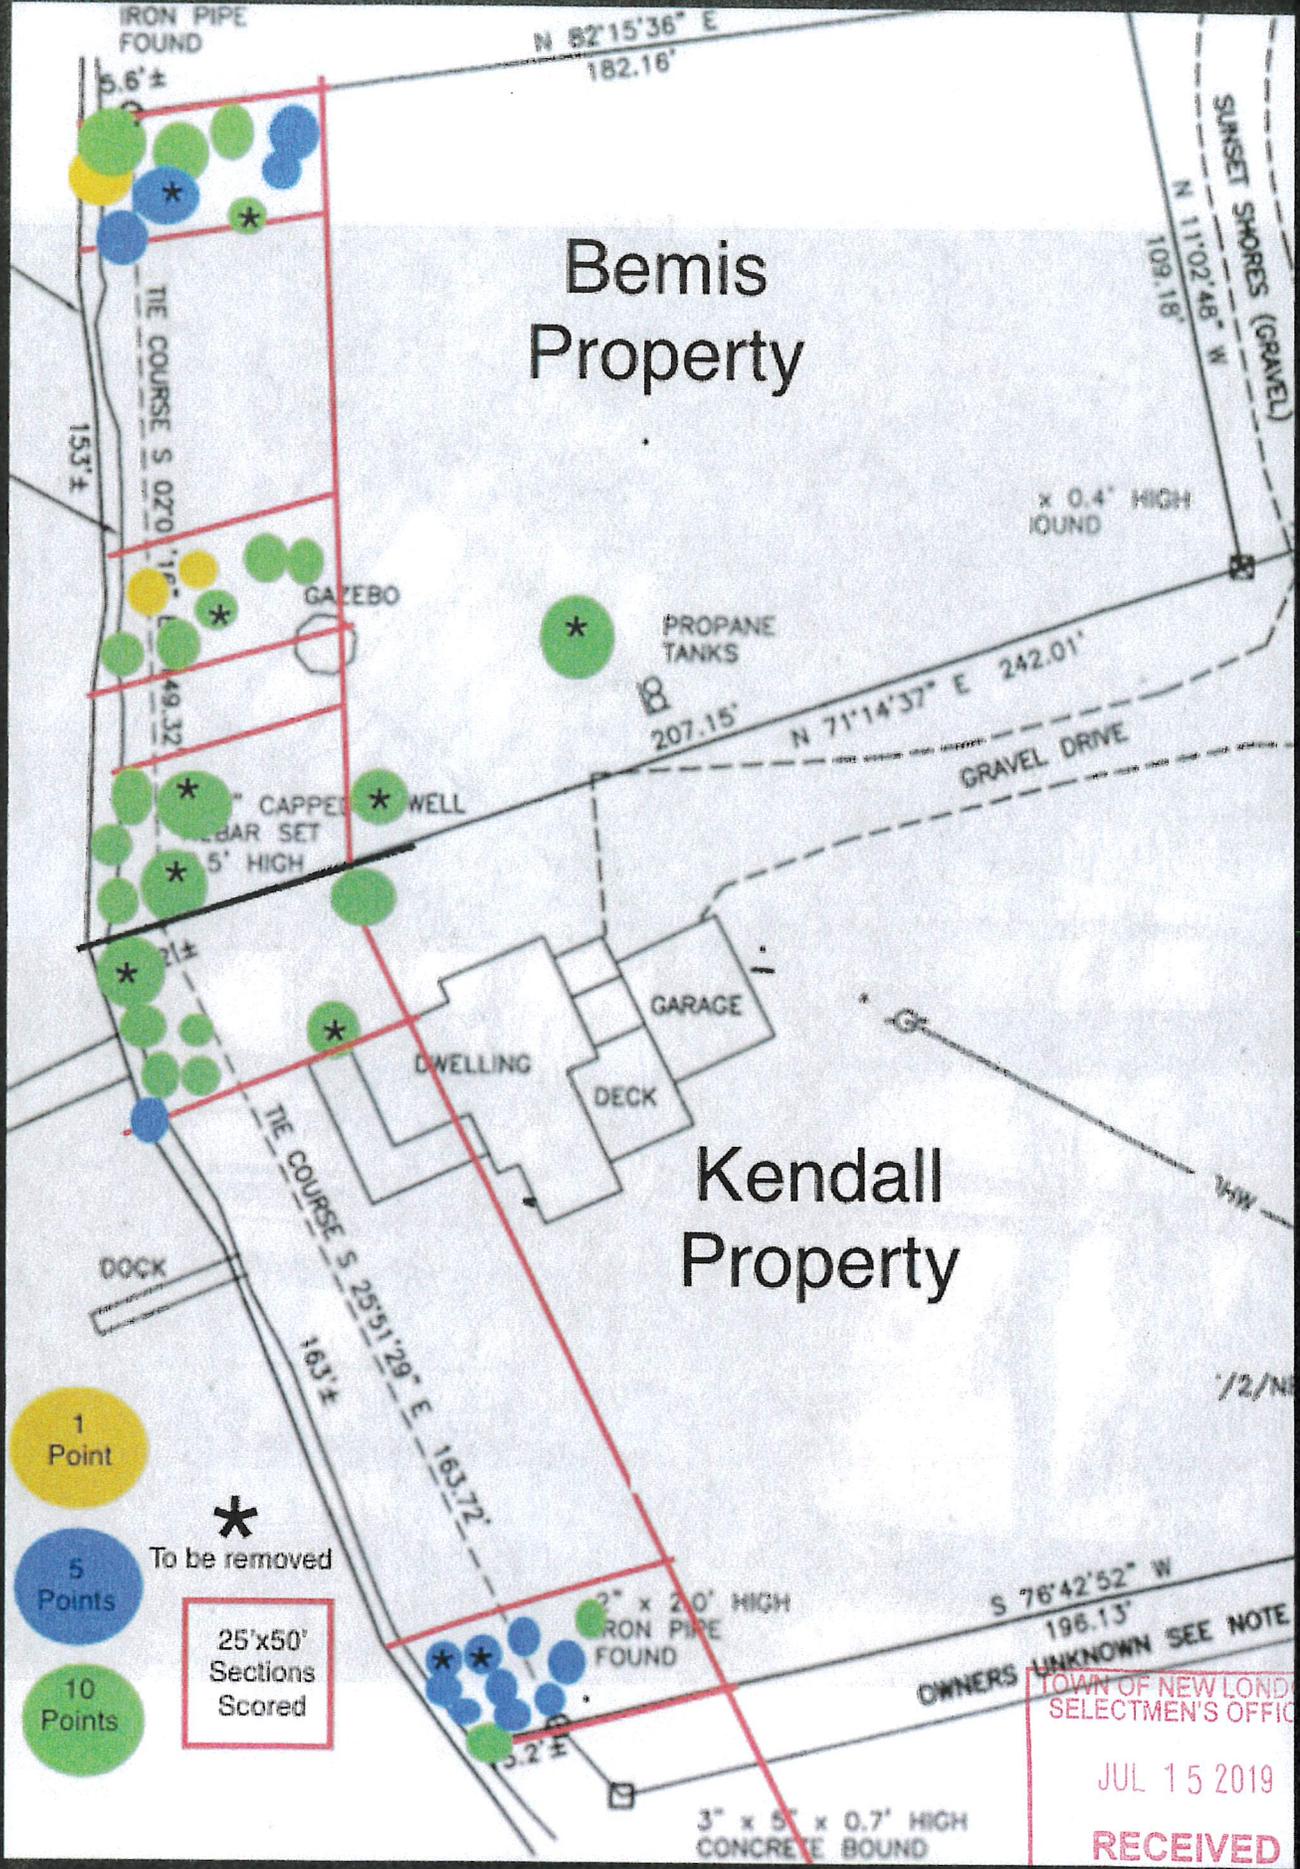
25'x50' SECTION SCORED

* To be removed

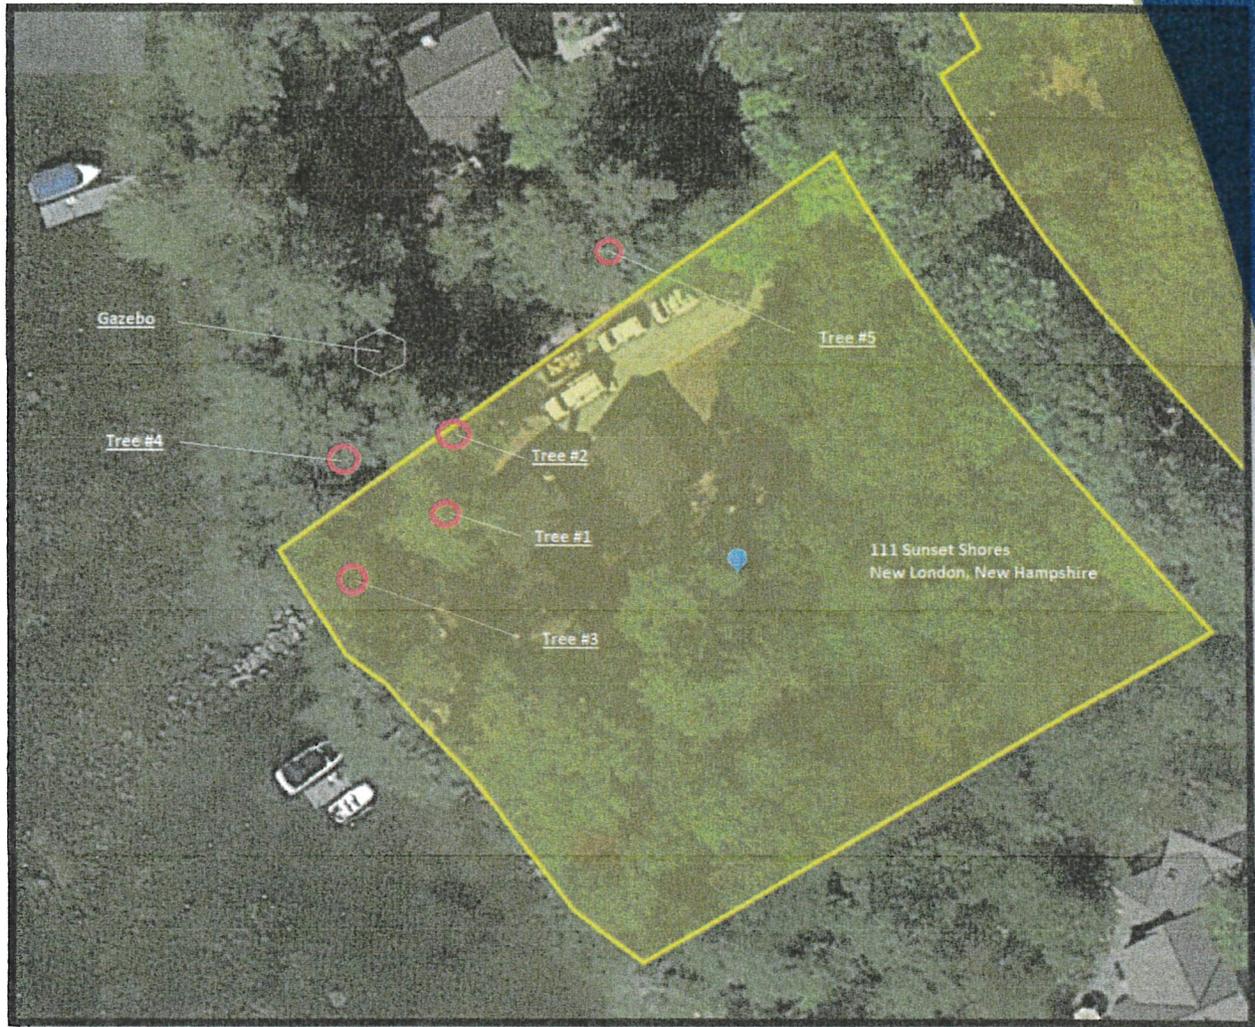
Site Map: 111 Sunset Shores, New London, New Hampshire

Tree #1 – Measured 98 feet height, 25 inches in diameter at 4.5 feet (DBH). Tree has a 6-degree lean to the east (house) and is 5.5 feet from the structure. Tree was drilled at 6 inches from ground and 4 feet from ground and no decay was detected by resistance measurement.

Tree #2 – Measured 103 feet height and 30.25 inches DBH. This tree has a 7.25-degree lean to the east and the garage corner. It is 29 feet from the house. No decay was detected, but a penetrometer soil probe revealed significant voids in the soil on the west side of the trunk. This suggests to me that the tree has recently shifted to the east and raised the ground as its roots lifted.

Tree #3 – Measured 95 feet height and 30 inches DBH. It has a 7.5-degree lean to the east and the house. It is 39 feet from the house. A decayed area was detected with the Resistograph at a depth of 4 inches on the west side near the base. The decay seems to be limited to this area because no decay was detected drilling to 12 inches from the east side. Pockets of decay do not always imply instability if there is sufficient sound wound encircling.

Tree #4 – Measured 96 feet height and 33.5 inches DBH. It has a 4-degree lean to the north and the Demis gazebo. It is 42 feet from the Kendall house. It was noted that the tree has a double leader crown structure. Although this can sometimes result in an elevated risk rating, no visible defects were observed from the ground. No decay was detected in this tree.

Tree #1, **Moderate Risk**

Tree #2, **High Risk**

Tree #3, **Moderate Risk**

Tree #4, **Moderate Risk**

There is a tree right of the driveway, and noted as #5 on the site map, that has woodpecker damage at about 50 feet. This tree should be inspected using an aerial lift for extent and severity of decay. The lower trunk appeared sound.

Tree #2 should be removed as soon as possible to avoid severe damage to the garage or house.

Trees #1, #3 and #4 should be monitored by a professional arborist for changes to structure and stability at least once a year and immediately after any significant wind or ice storms. The current lean of these trees is considered "natural" but they should be monitored for any further movement.
