Intent to Complete Repairs (Updated)
DAM #D176002/DSP #15-019
DAM Pleasant Lake Dam

RE: Letter of Deficiency: Issued on July 15, 2015, Updated on September 17, 2015

Dam #D176002, Pleasant Lake Dam, Inspected 05/22/15

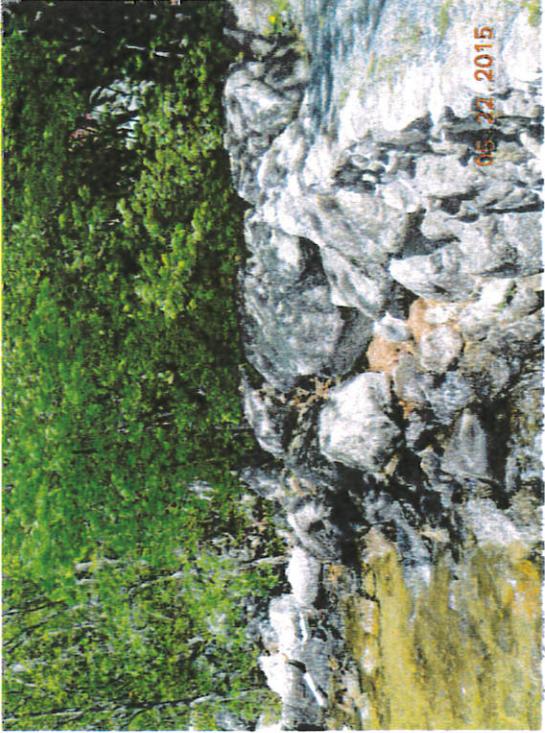
E

- d. Clearing and regrading the left abutment of the dam such that it has a proper cross-sectional shape and is consistent in elevation with the remainder of the dam. (See photo E).

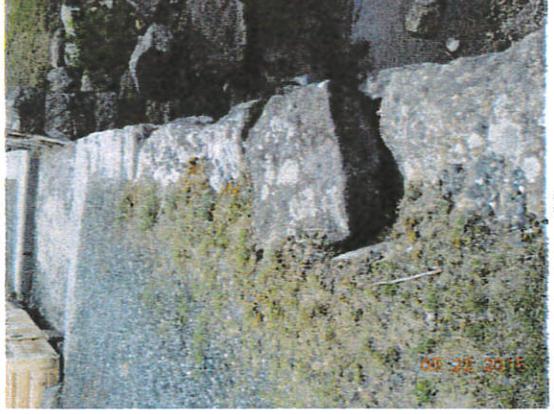
H

1. Cut all trees, brush and weedy growth from the footprint (earthen embankment) of the dam and 15 ft beyond the footprint of the dam to prevent damage to the dam from root penetration, blow down of the trees and to create a buffer zone to monitor the dam for seepage and other maintenance concerns. Areas to clear include (but not limited to):
 - a. The auxiliary spillway which is full of debris that also needs to be removed. (See photos A and B).
 - b. Highlighted bushes to the left of the outlet structure. (See photo C).
 - c. Highlighted bushes to the right of the outlet structure. (See photo D).
2. Patch and repair the void in the masonry face of the dam at the intersection with the trash rack, left of the gatehouse. (See photo G).
3. Backfill and compact, with appropriate soil material, the void to the right of the gatehouse in the downstream stonewall of the dam. (See photo H).

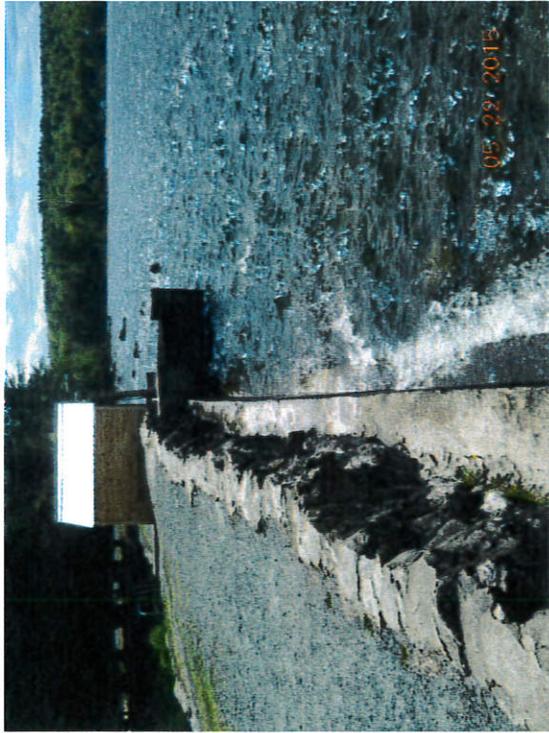
I

- a. Regrading the crest of the dam along its entire length to establish a 6' wide (upstream to downstream) level surface. (See photo I).
 - b. Loaming, seeding and revegetating all areas of limited grass growth along the crest and downstream portions of the dam. (See photo J for an example).

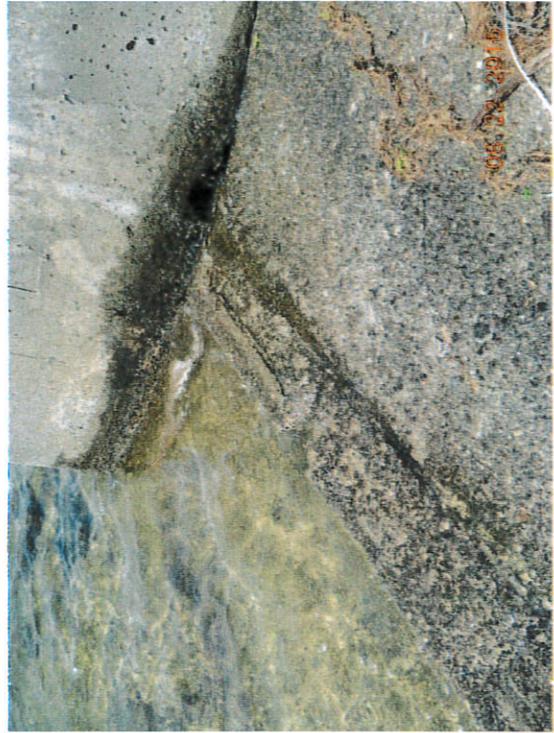
K

6. Monitor the concrete cracks and/or degradation in the following locations:
 - a. Left training wall with the horizontal slab of the spillway. (See photo K).
 - b. Right training wall of the spillway. (See photo L).
 - c. Masonry face of the dam along the left abutment that doesn't have the concrete facing/protection. (See photo M).
 - d. Old concrete facing of the dam to the right of the gatehouse that was sealed appears to be shrinking and cracking. (See photos N and O).
 - e. Interface between old concrete facing of the dam with masonry. (See photo P).
7. Monitor riprap facing of the embankment dam that is exposed to wave action of the lake along the left abutment. (See photos Q and R).

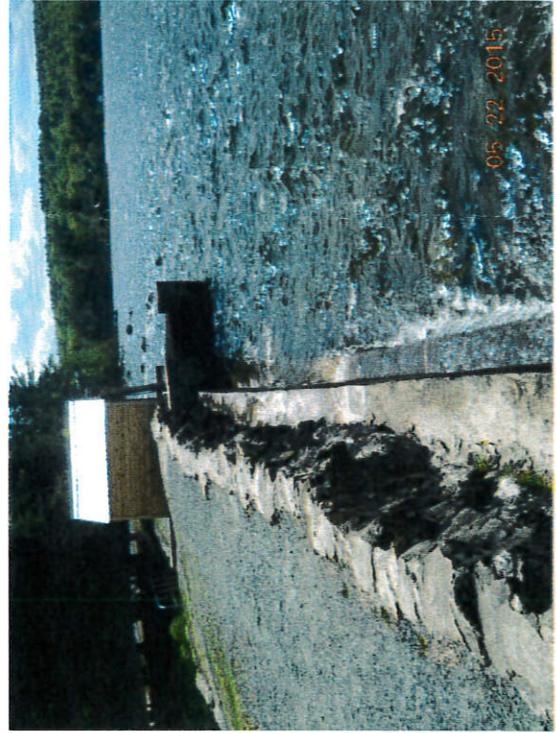
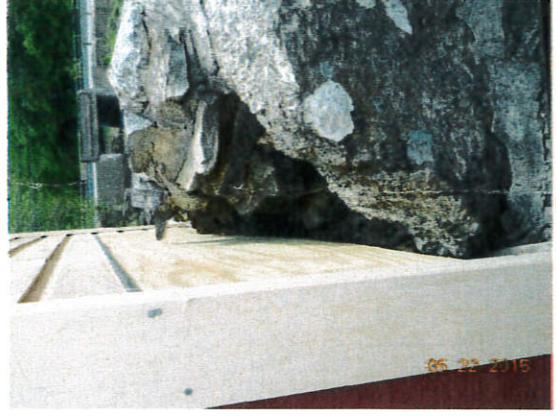
- c. Reconstructing or modifying the gatehouse foundation and adjacent crest to establish a consistent elevation and smooth transition on both sides. (See photos S, T and U).

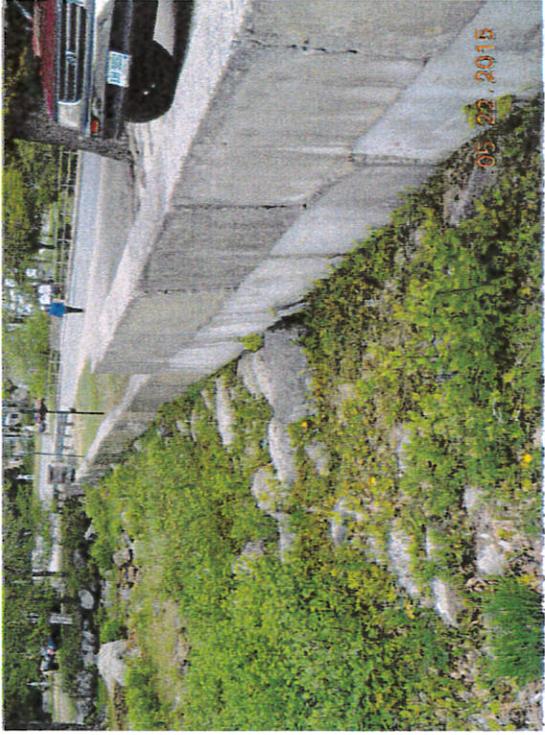
V

- e. Mortaring or somehow binding the individual blocks of the auxiliary spillway to prevent movement during spillway activation. (See photo V).
