Re: File # 2015-01284  
Project Name: Judith R Breed Revocable Trust  
Location: 47 Moyah's Lane, New London, NH  
Tax Map/ Lot #103/ 12

**DESCRIPTION**  
Breed Shoreland Restoration

Title **Proposed Wetlands Plan**

Project: Breed Property  
Title: Revised Cross-Section B-B'

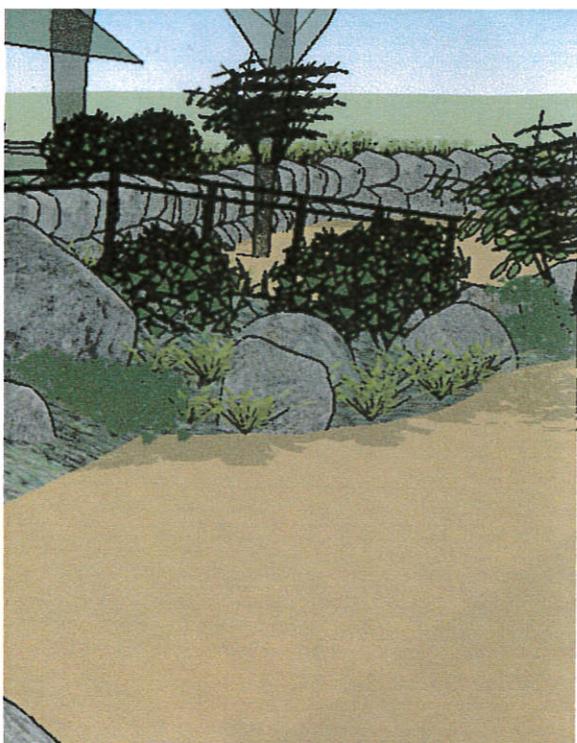
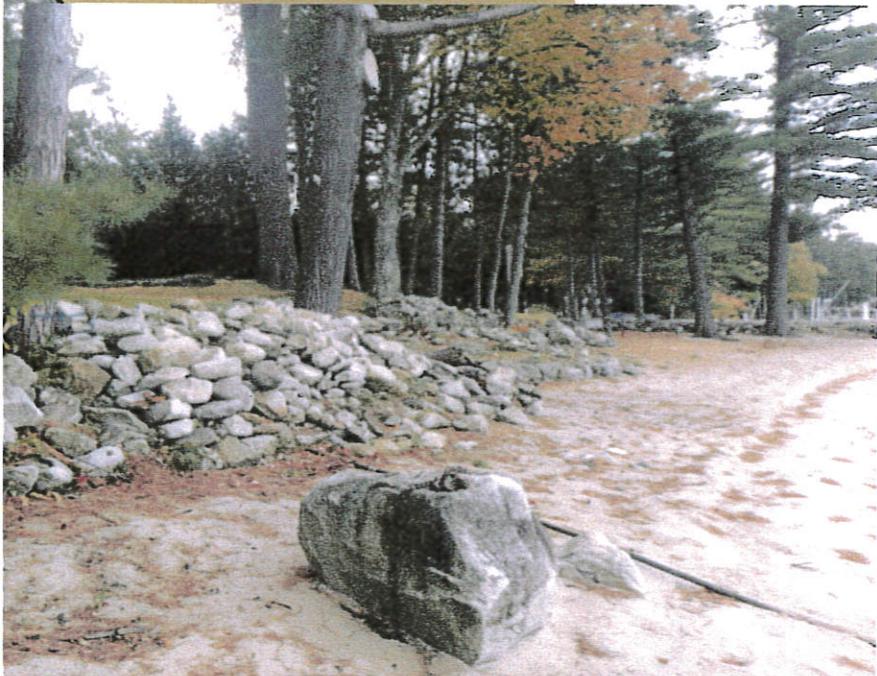
01

**Existing Conditions**

Between the restored shoreline, and the rebuilt wall, there will be a 6' wide permanent footpath to the beach area, in accordance with RSA 483-B:9 V(a)(2)(D)(ix). This path will have a handrail adjacent to it for those with limited mobility. Please see the attached sheet (L 01) containing existing condition photos, adjacent to 3-D renderings, showing the proposed relationship of the aforementioned elements.

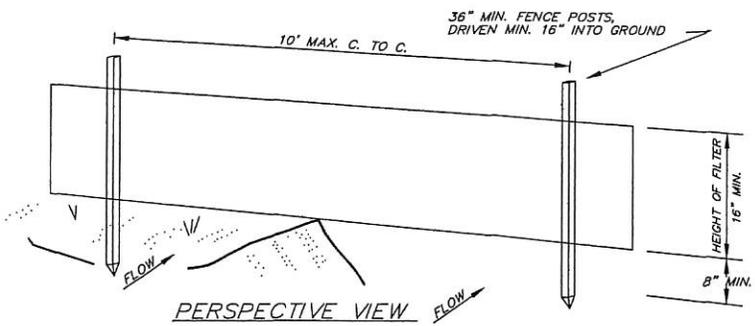
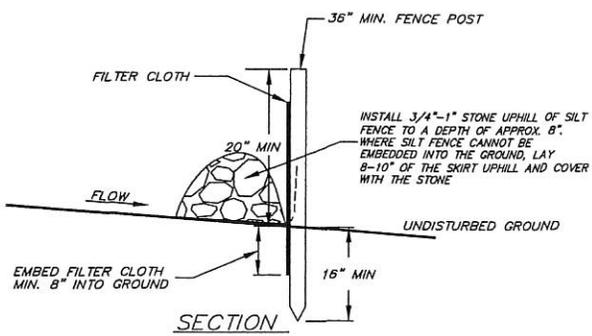
**SILT FENCE DETAIL**  
(NOT TO SCALE)

1. FILTER CLOTH TO BE FASTENED SECURELY TO FENCE POST WITH TIES AT TOP, MID SECTION AND BOTTOM.
2. WHEN TWO SECTIONS OF FILTER CLOTH ADJOIN EACH OTHER, THEY SHALL BE OVERLAPPED BY 6 INCHES, FOLDED STAPLED.
3. MAINTENANCE SHALL BE PERFORMED AS NEEDED TO PREVENT "BULGES" IN THE SILT FENCE DUE TO DEPOSITION OF SEDIMENT.
