Bucklin Farm

Morgan Hill Road
New London, New Hampshire

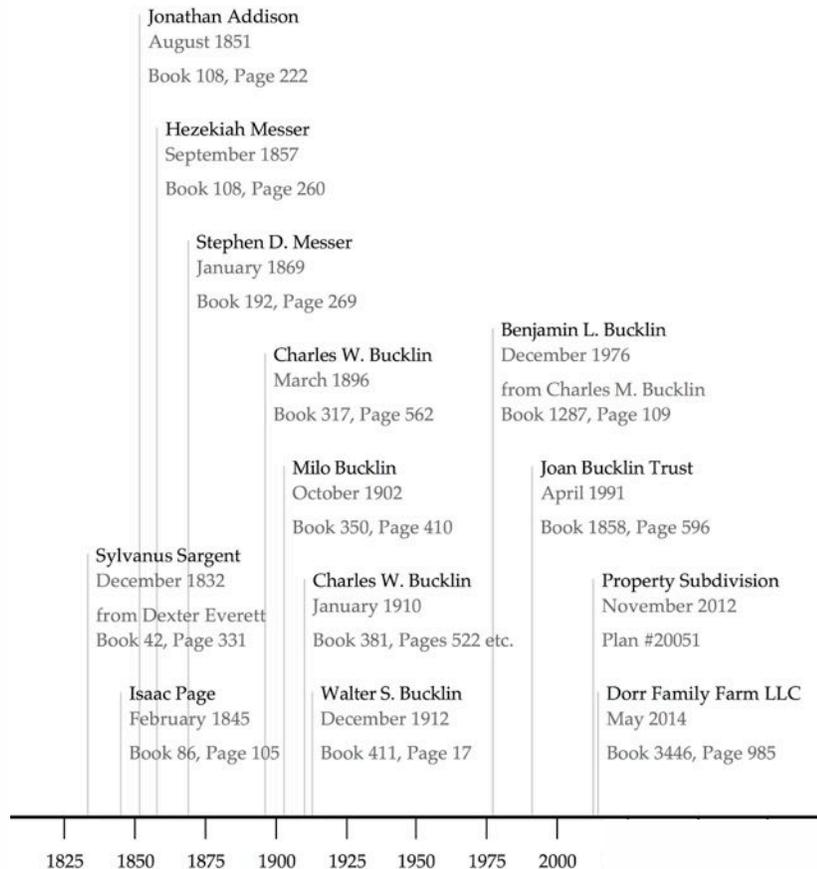
Figure 1.

Deed timeline for the farmstead property. Merrimack County Registry of Deeds.

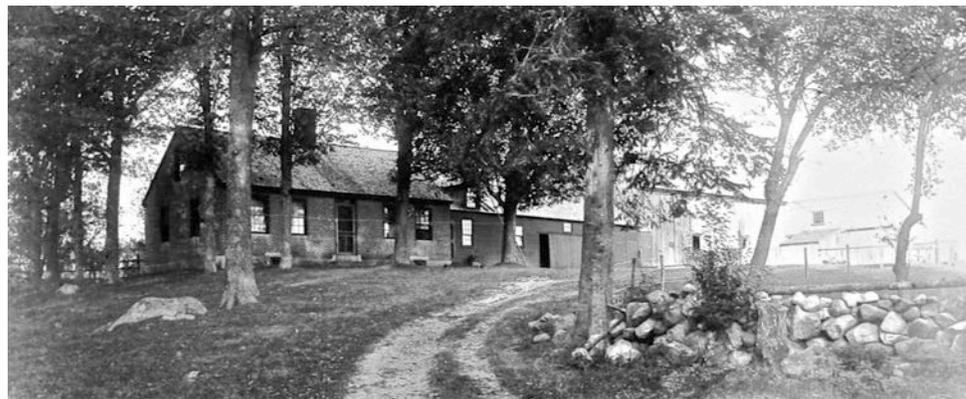
Figure 2.

The Stephen D. Messer farmstead as it appeared in the 1890s.

A single 1890s photograph (Figure 2) provides the only evidence yet discovered of the farmstead's appearance around the time that Charles W. Bucklin purchased it from Stephen D. Messer in 1896.³² Subsequent changes may be found by investigation of the standing structure, but what happened between 1832 and 1896, we will probably never know with certainty. Census and tax records offer intermittent snapshots of the farm's size and output, which may correlate with the type and size of buildings required to support the activity.

Taken at the end of the Messer period, the archival photograph (Figure 2) shows three of the basic elements of the familiar connected farm plan: house, ell, and barn.³³ Within the farmstead's building timeline, only the date of the brick house is nearly certain. Statistical and empirical evidence of northern New

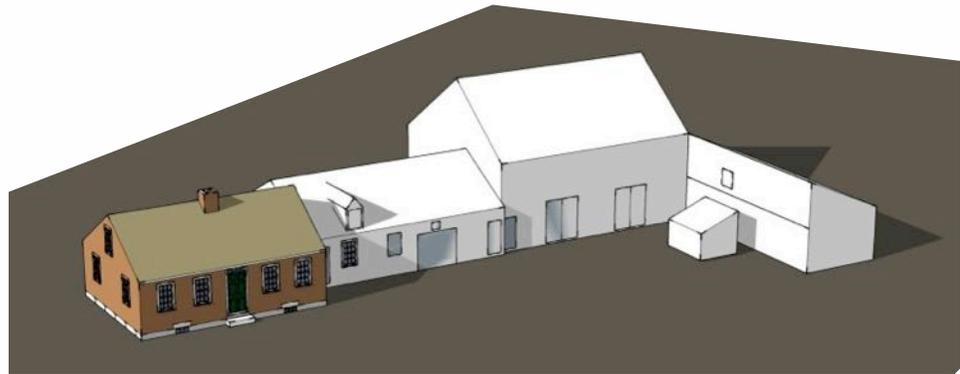
Figure 3.
Messer farmstead
model showing the
arrangement of
connected buildings.

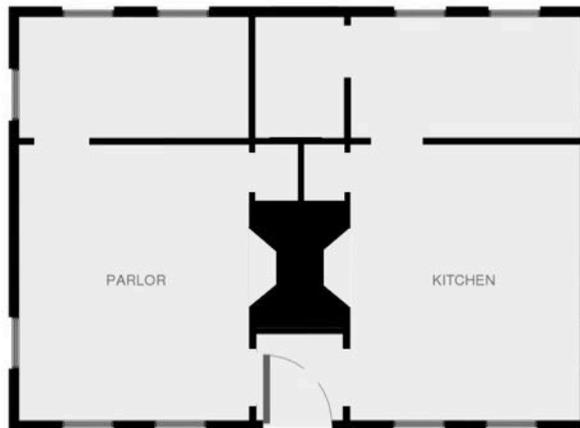
Figure 4.
Conjectural plan of
original farmhouse,
before connecting ell.

During the Sargent-Messer period, the first floor space at the rear might have been used as a bedroom or pantry, and a now-exposed overhead beam marks a likely partition from the kitchen. The parlor might also have been used as a bedroom, as was common practice.³⁴ (In recent years, maybe longer, it has been a bedroom.) With a window in either gable, there may have been finished bedrooms upstairs as well, though the functional area was limited by headroom under the low, pitched roof. Nevertheless, the house (and ell) probably offered adequate accommodations for Hezekiah and Sophronia Messer and two of their adult children.

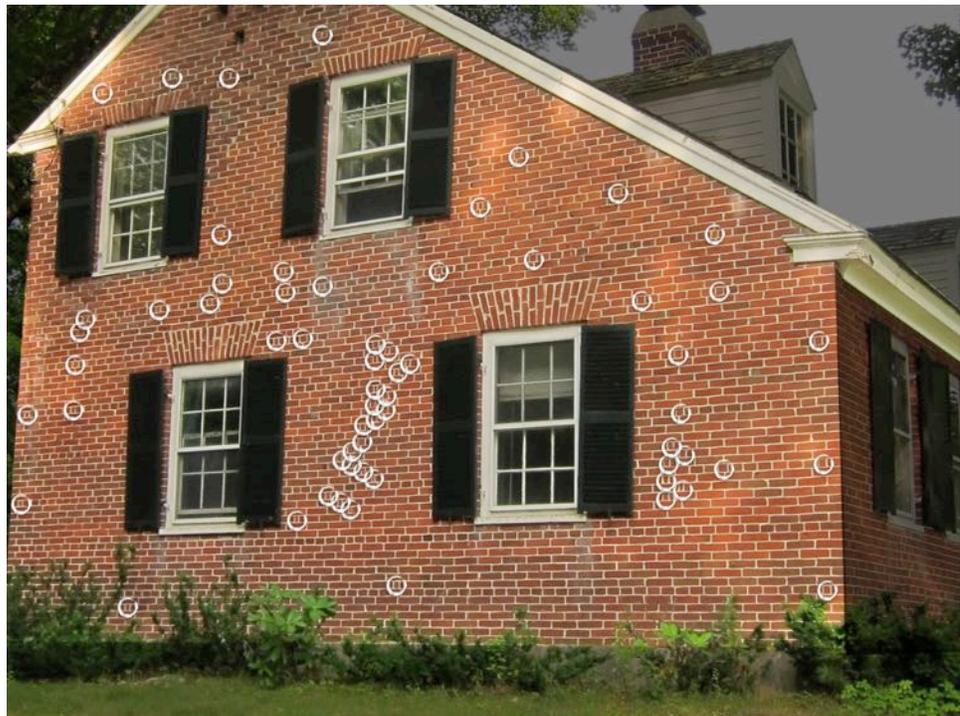
Figure 5.

Sylvanus Sargent house, west gable. Locations of brick closers marked. The new section at the upper left is a veneer.

The brick bonding of six stretcher courses followed by one of headers is a common pattern, but the somewhat haphazard use of closers (partial bricks) in order to maintain the desired spacing suggests that the house was built by an unpracticed mason. This evidence supports the notion that the house was constructed using local materials and labor—obtained where masonry experience was strictly limited to chimneys and fireplaces.³⁹

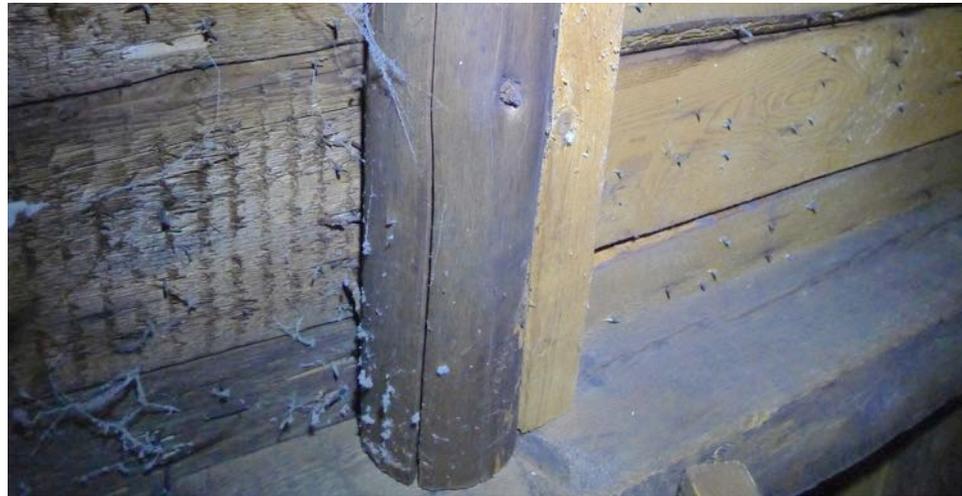
Figure 6.

Old meets new at the transition point between the 1830s ridge and the 1920s roof extension.

Probably in the 1920s, the house roof was raised in the rear and extended in the front, above the chimney. The rear section appears to be the original material simply disconnected from the original wall, raised vertically about five feet, and reattached to new framing. In order to keep the original pitch, the roof was extended in front using new materials but old techniques (i.e. purlins and vertical roof boards). Through a ceiling portal the original ridgepole is still visible at the upper edge of the chimney penetration. Blown-in insulation now

obstructs the view of most framing members, but at the transition point there is a clear contrast between the older, vertically-sawn boards and the newer, circular-sawn boards (Figure 6). The east gable has been converted to clapboards above the first floor, and the expanded area on the west gable was infilled with brick veneer, probably with bricks from the opposite gable. At the rear, the entire second floor is clapboarded and a new exterior chimney has been built for a furnace. The enlarged roof is covered in wood shingles as it was originally. A copper ice belt has since been added above the eaves and first appears in photographs taken around 1950.

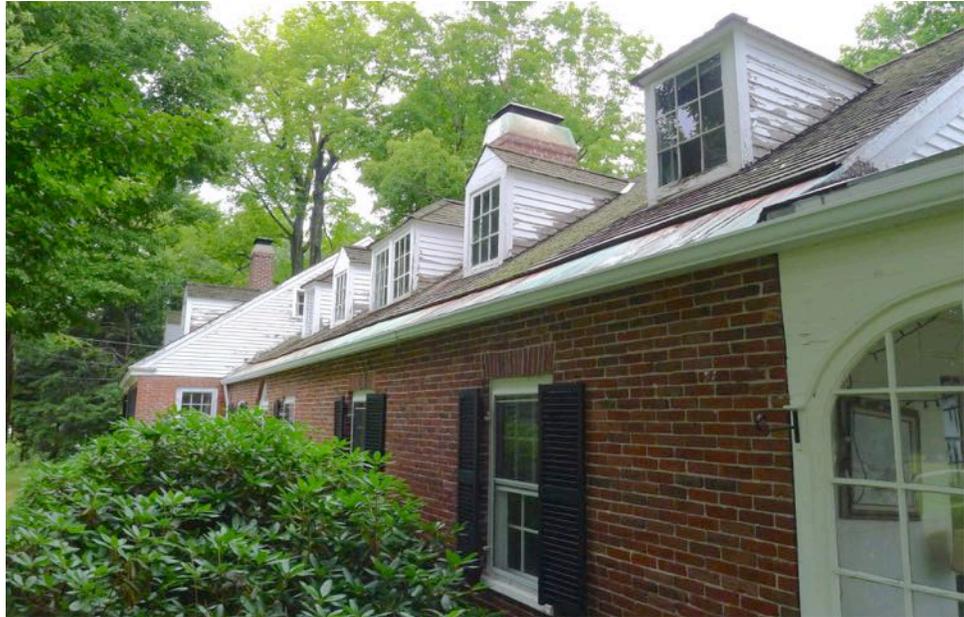
Figure 7.

Brick veneer on the enlarged ell, with five dormers above; the new enclosed porch with flat roof appears to the right.

The ell joining the house with the barn was much altered by the renovations of the 1920s. In order to expand living space for the Bucklin family and its household staff, the ell was widened on both sides and perhaps lengthened at the east end. A poured concrete foundation now supports the structure, but sections of 19th century construction may still be seen at both the basement and attic levels.

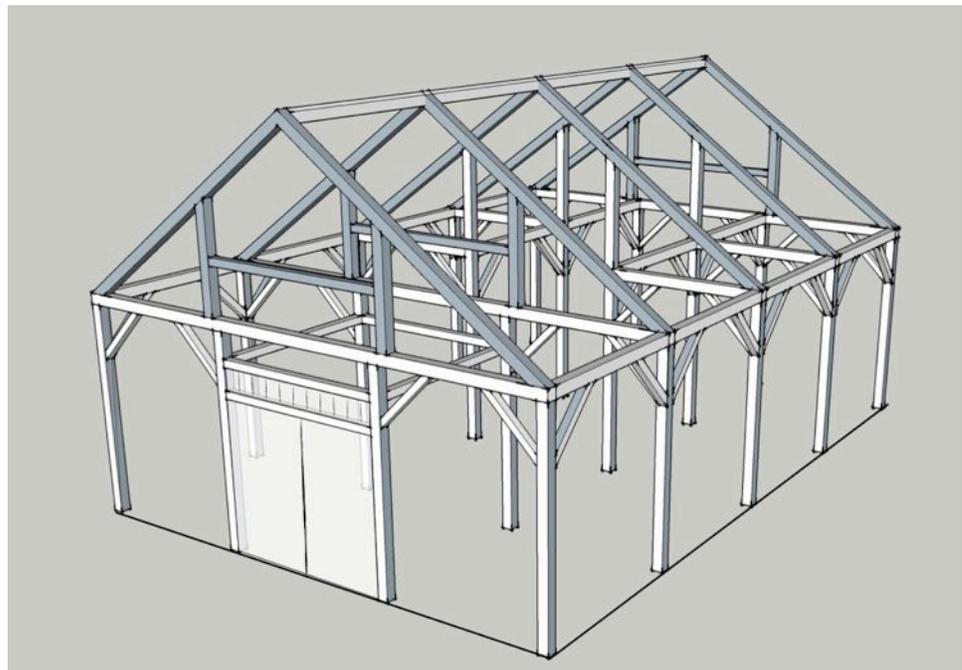
Figure 8.

Simplified framing diagram of the barn, before dairy lean-to addition.

The date of the New England style (gable entry) barn, measuring 36' x 48', is unknown. Its design and construction would have been somewhat advanced for the 1830s, but the date is not beyond possibility. The simplified framing of the bents combines hewn 8" x 8" posts, beams and major rafters, with lesser sawn bracing. The twelve bays (3 x 4) are each nearly 12' square, displaying a regularity that became more common around mid-century with new farming practices and the invention of labor-saving devices. Utilizing standardized bays, hay lofts were easily built and dismantled in stages re-using lumber of uniform dimensions; animal stalls and equipment storage could be similarly rearranged on the ground level as needs changed.

During the Bucklins' renovation of the house, the barn was moved onto a new foundation farther north-east of the residence, and a 14' x 48' lean-to was added to the north side in order to accommodate cow pens for the dairy. The three bays along the east end were enclosed on the first story, and this 12' x 36' area was equipped as a milking parlor. Four bays in the south-west corner, nearest the house, was similarly walled off and outfitted with box stalls for horses. One bay at the north-west corner was excavated to a depth of three feet, with concrete floor and concrete walls poured up to the level of the barn floor, creating a convenient ice-house within the barn.⁴⁶ The barn floor is now concrete. Facing the asphalt parking area, within the second bay (between the horse stalls and

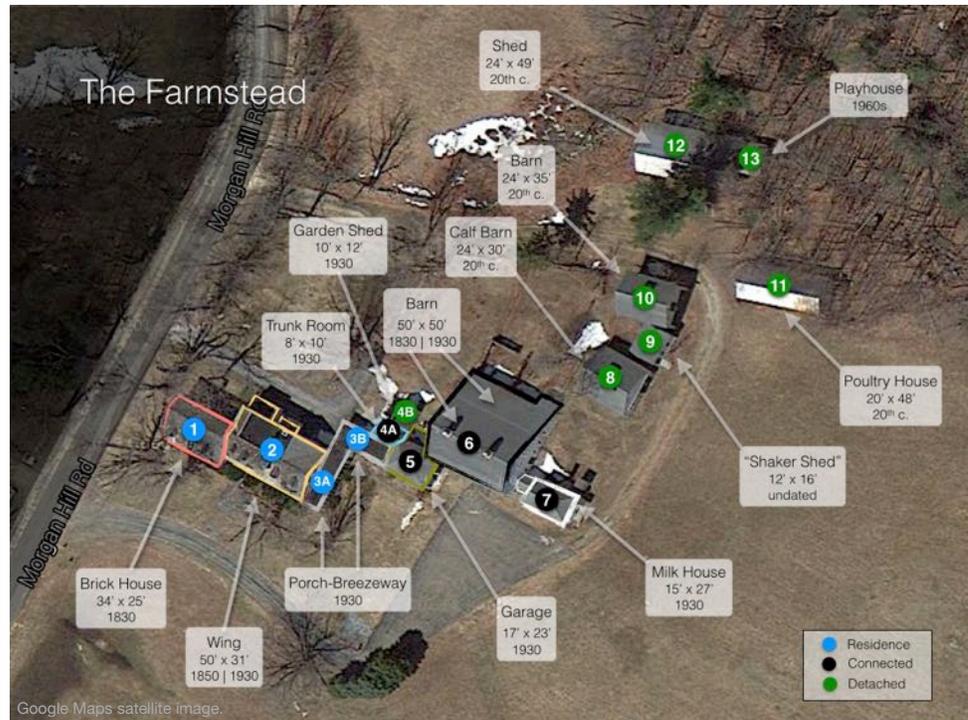
Figure 10.
Bucklin Farm complex.
Functional components
and outbuildings
labeled with
approximate
construction dates.

Although at least two outbuildings appear in the 1890s photograph, a brief look at the six detached structures now on the property did not show any dating from that period, nor do any match the shed designs that appear in the image. A closer inspection might prove otherwise, but it's likely that these impermanent structures were not considered worth preserving during the extensive renovation of the 1920s, and they were simply replaced by a new set of small barns and sheds built for new purposes.
