Buker Building Study

Facility Assessment, Space Needs, & Concept
Design Alternatives
New London, NH

Board of Selectmen Presentation

20 August 2018

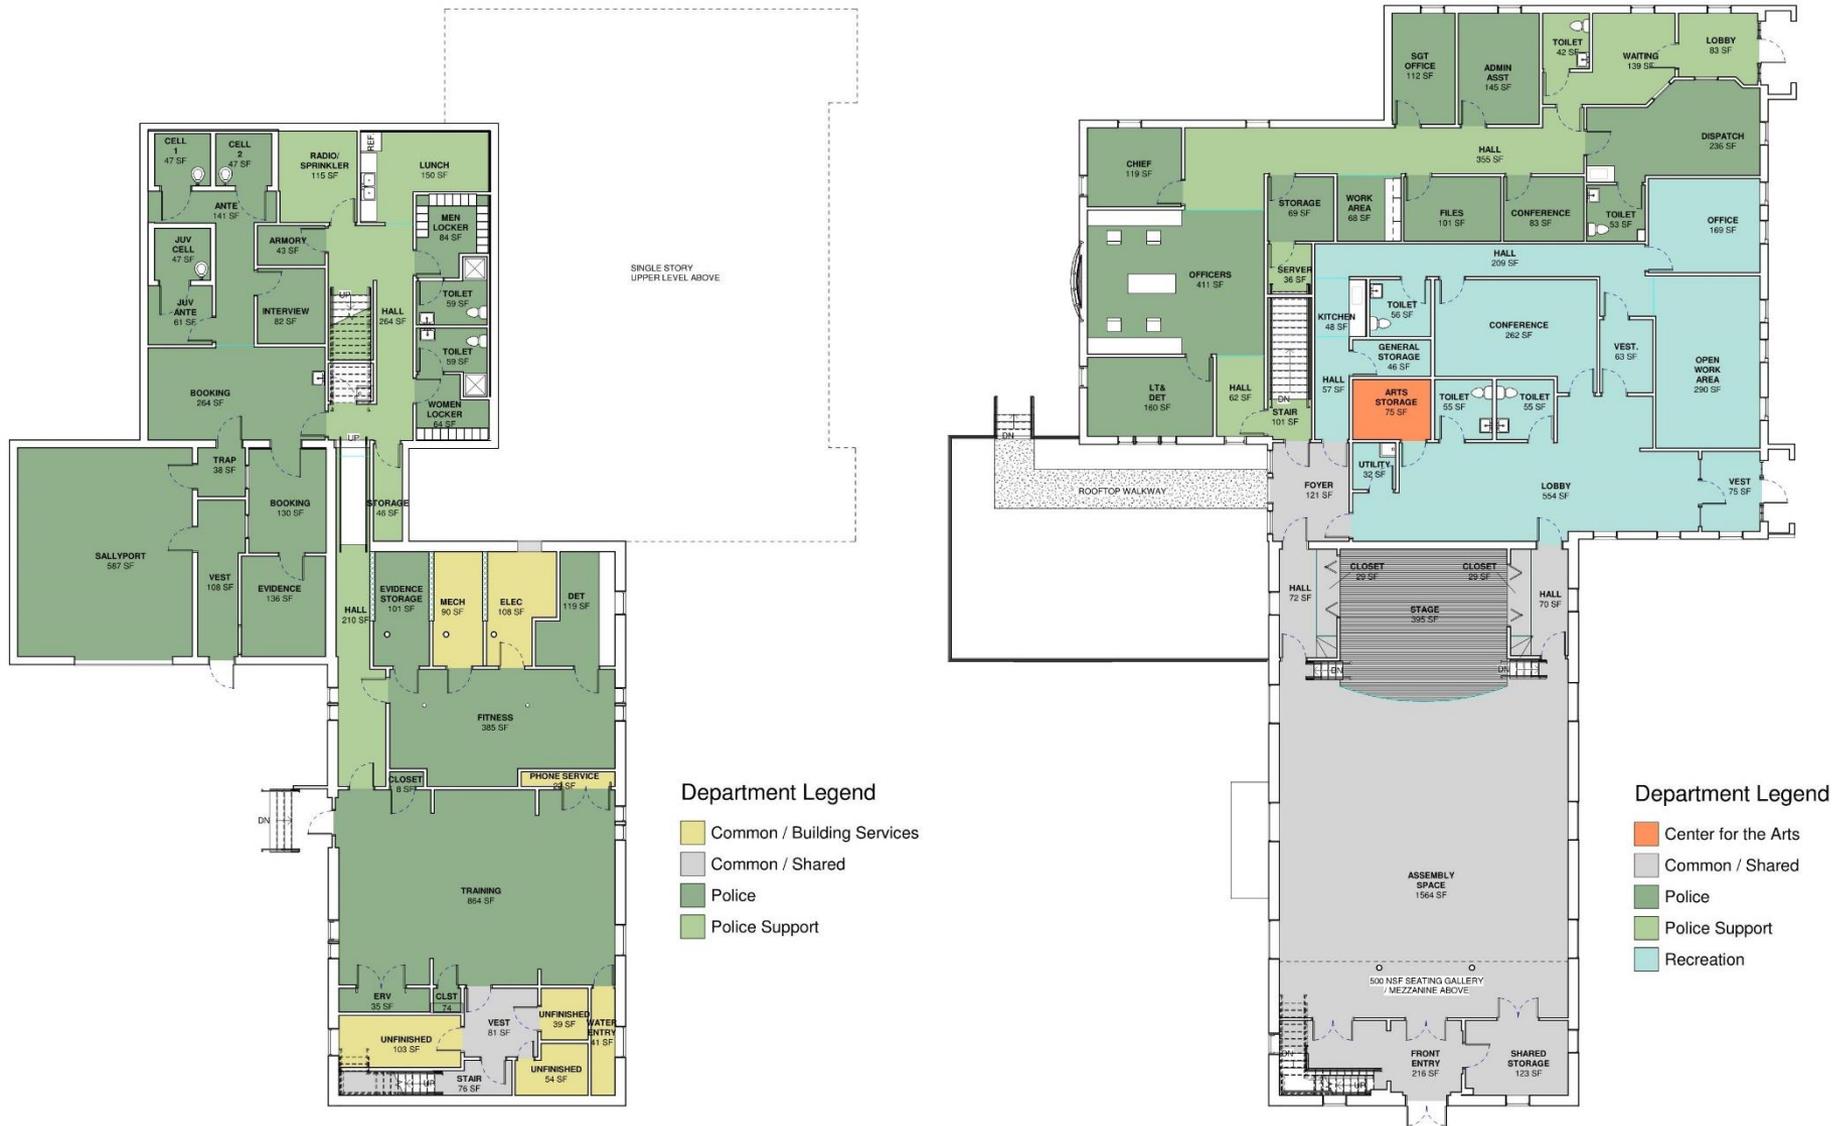
Existing Space Analysis – Area by Department

Existing Lower Level

Existing Upper Level

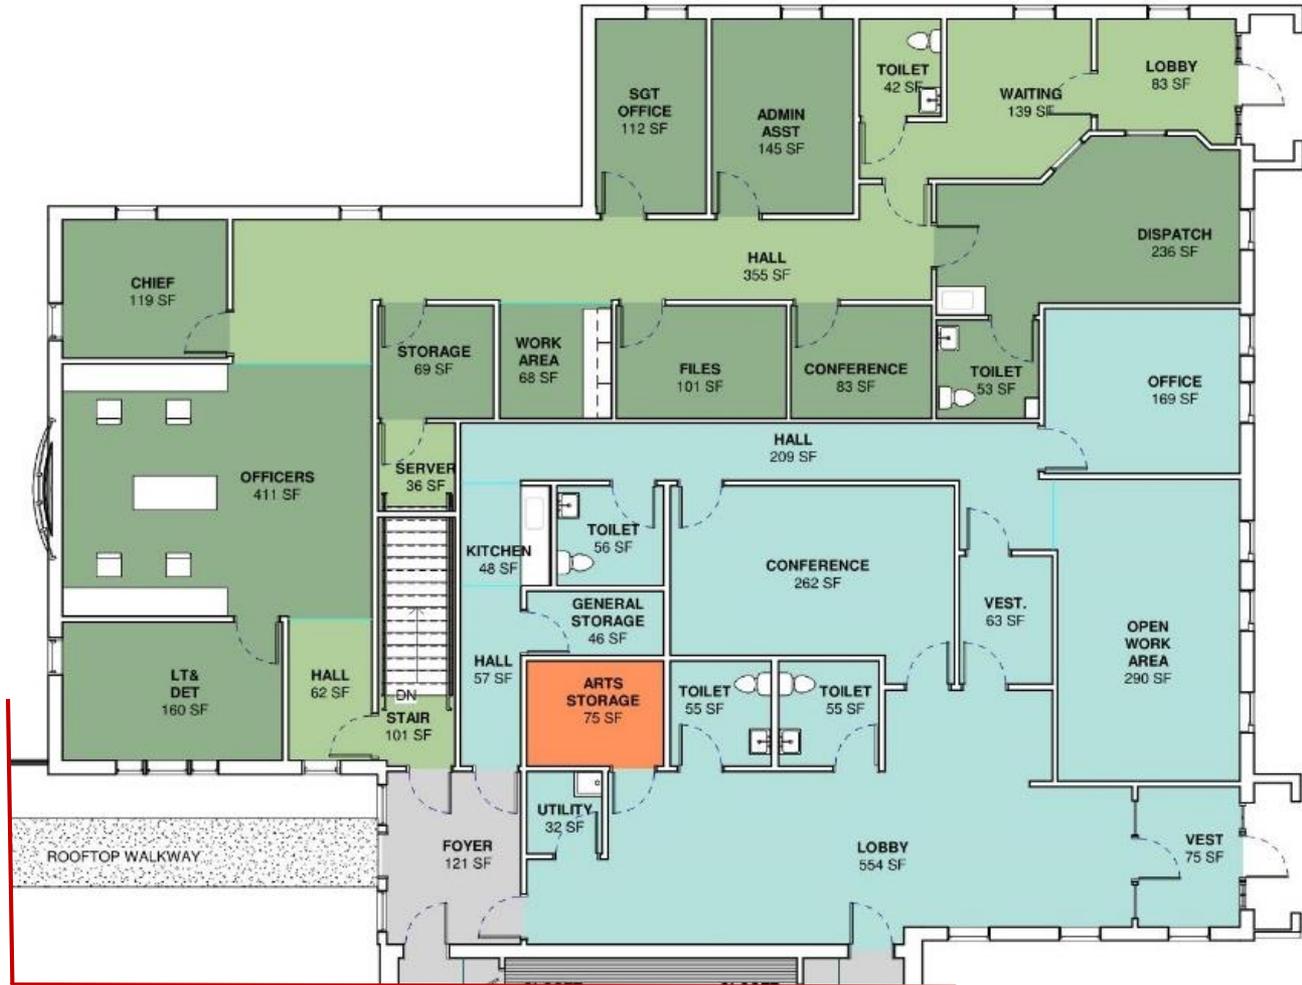
Existing Upper Level (Buker) – Recreation, CFTA, and Police

- Center for the Arts
- Common / Shared
- Police
- Police Support
- Recreation

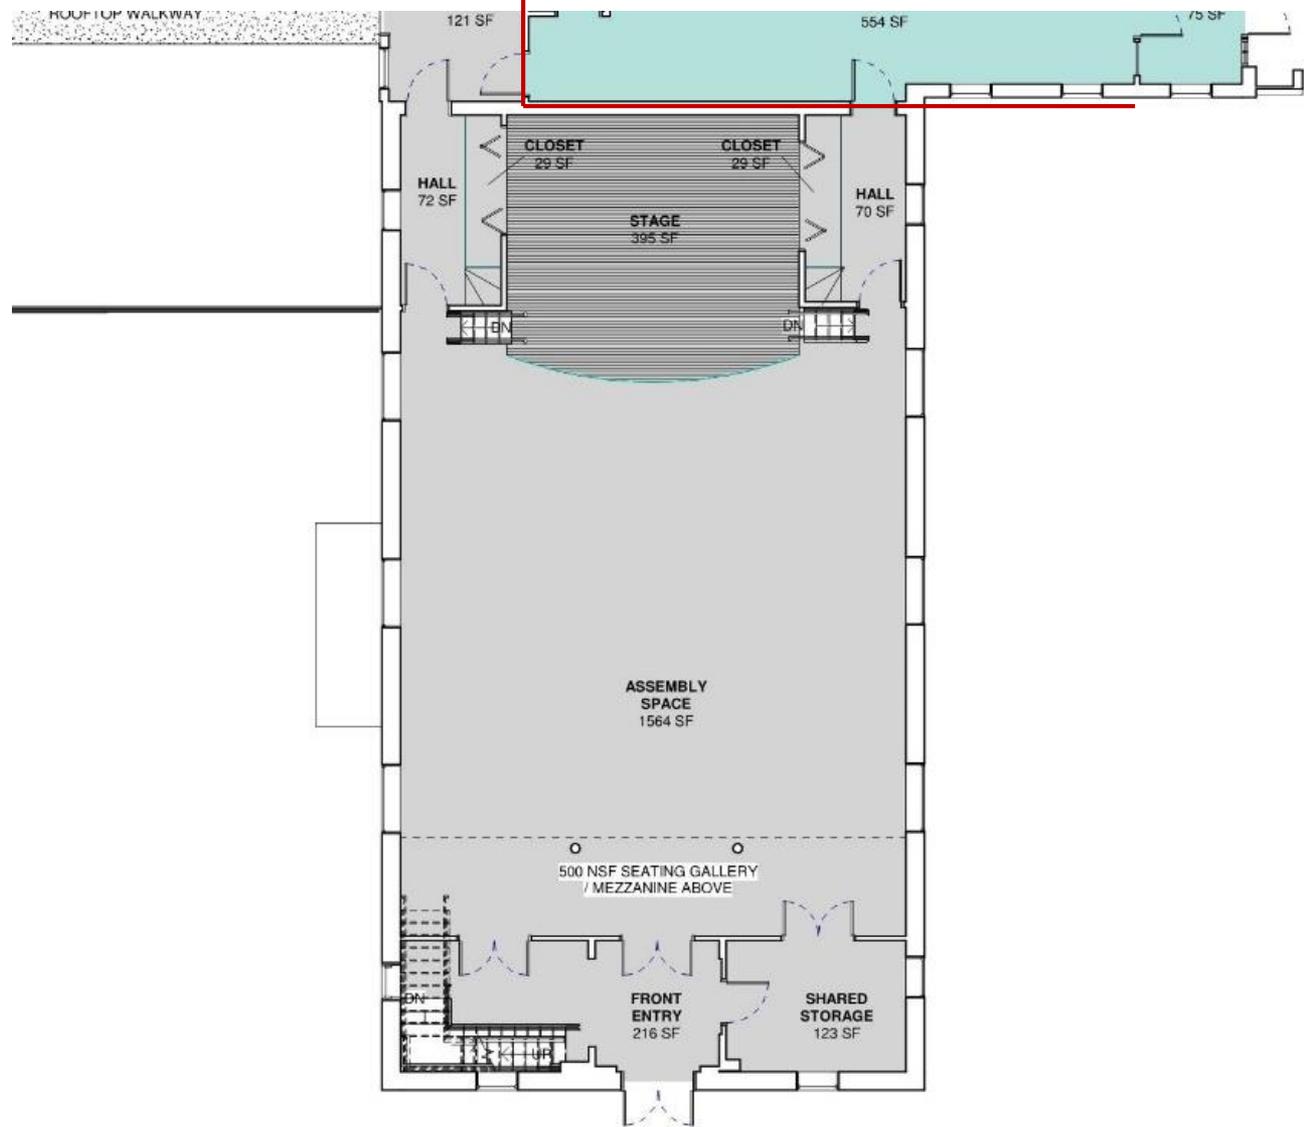
Existing Upper Level (Whipple) – Common / Shared Areas

- Center for the Arts
- Common / Shared
- Police
- Police Support
- Recreation

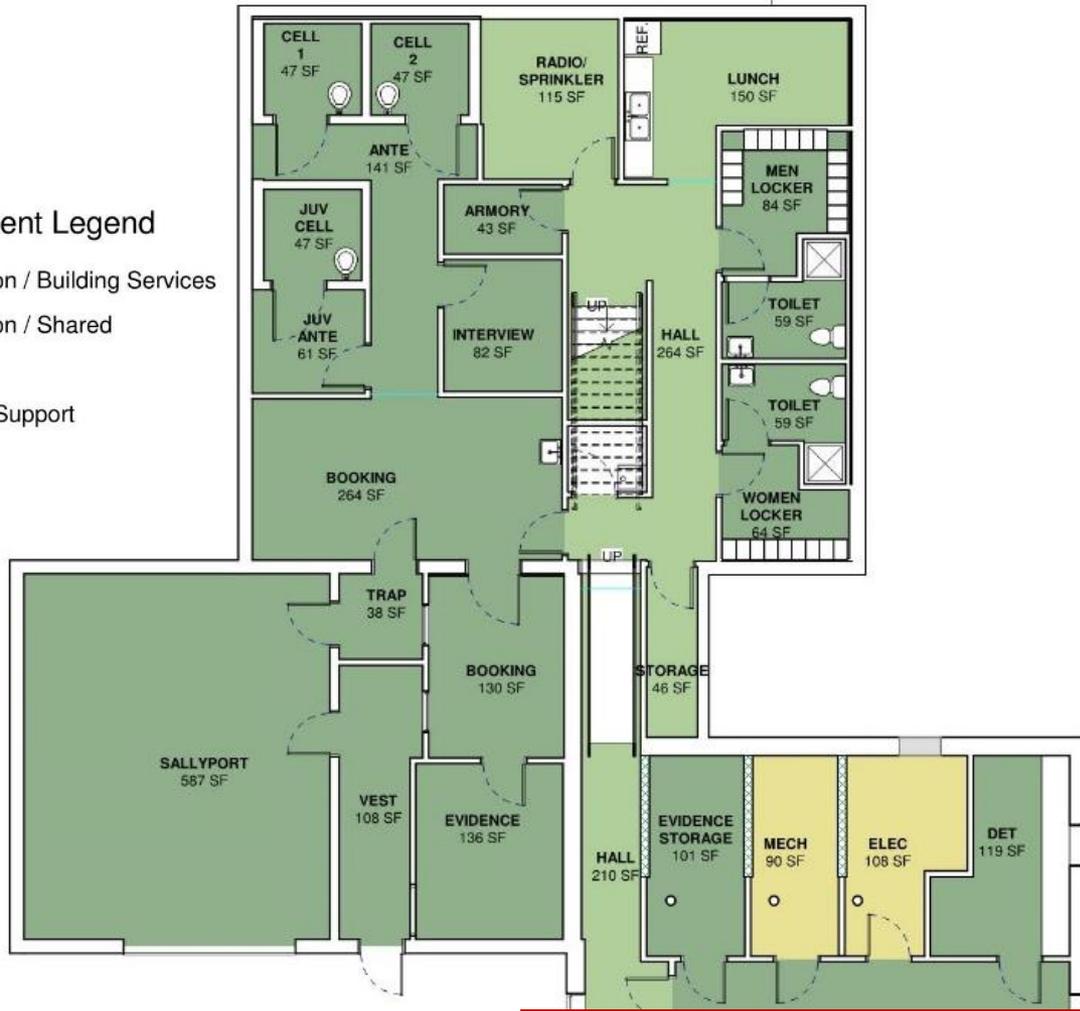
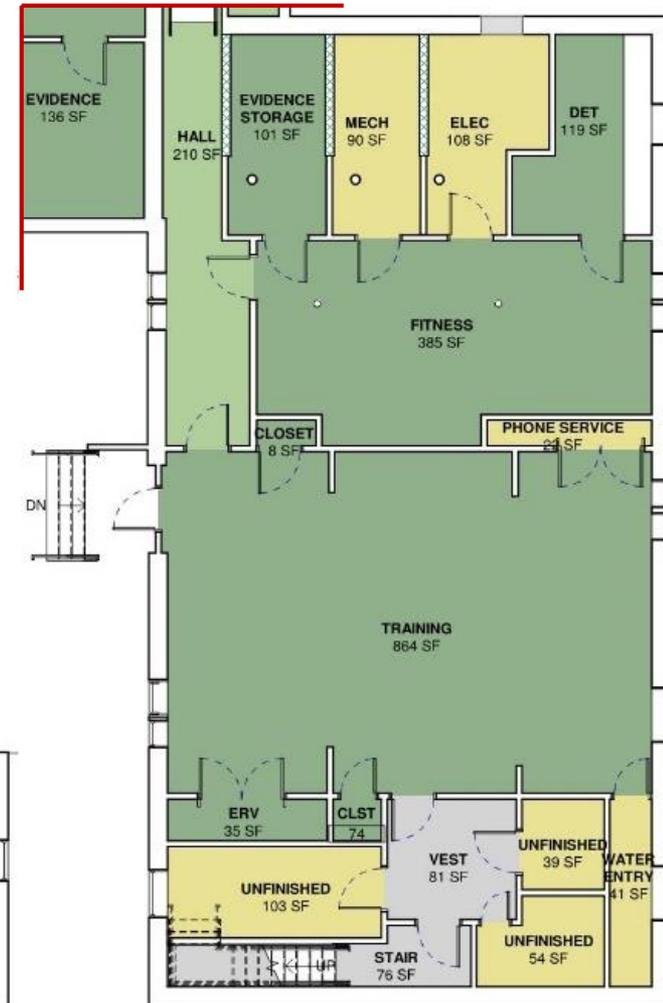
Existing Lower Level (Buker & Whipple) – Police and Building Services

- Common / Building Services
- Common / Shared
- Police
- Police Support

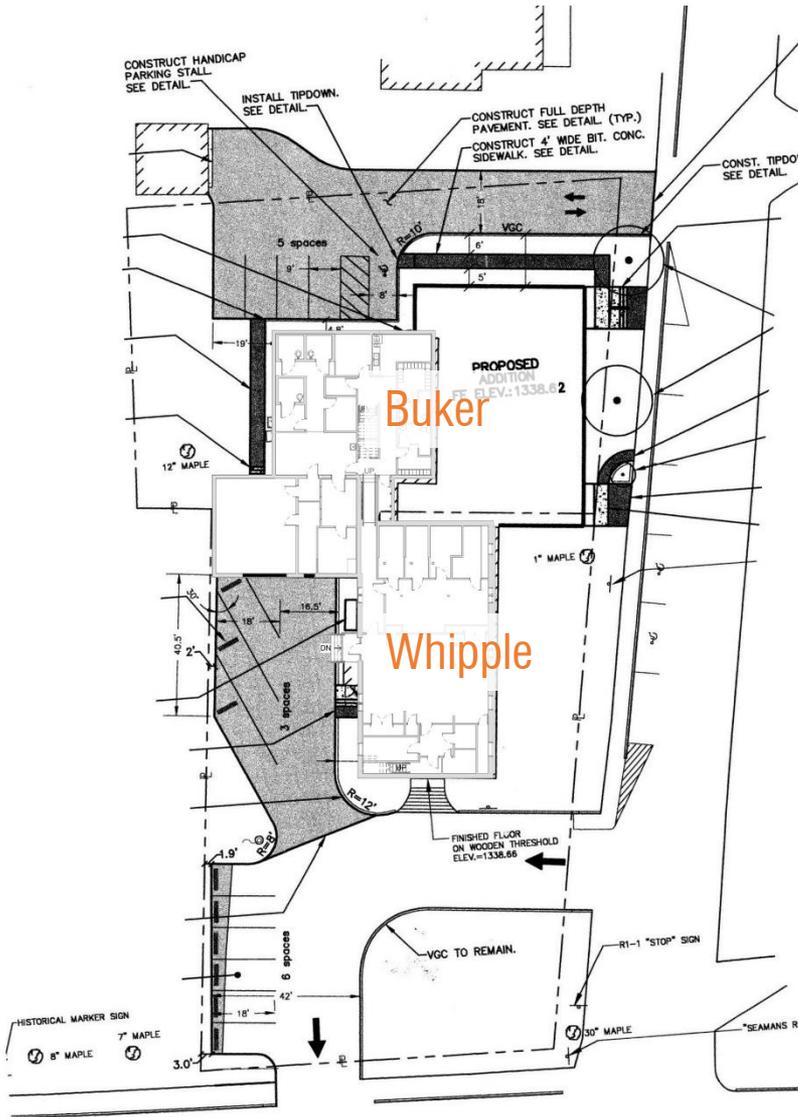
1 FIRST FLOOR PLAN
SCALE: 1/16" = 1'-0"

Existing Conditions

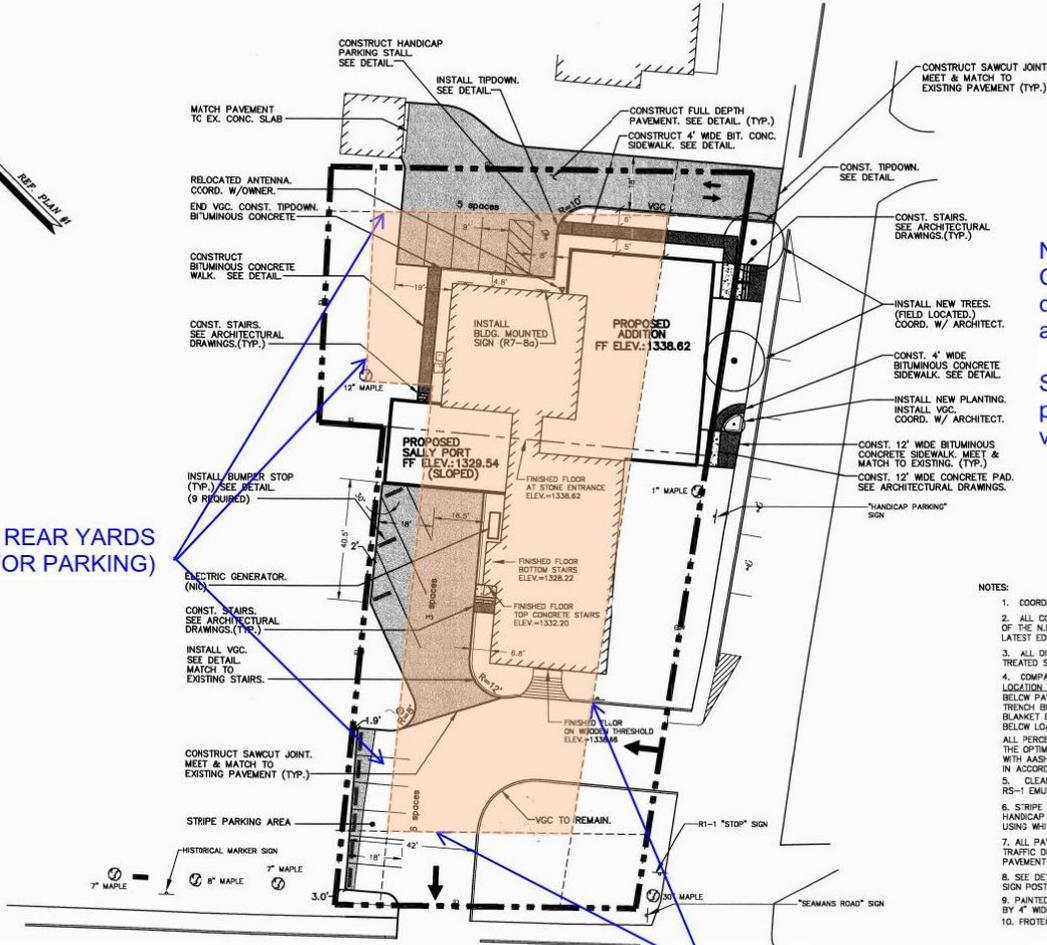
Existing Conditions: Site Parameters

15' SIDE & REAR YARDS
(25' MAY BE REQUIRED FOR PARKING)

Note:
Check easement agreement for driveway and parking shared w/ abutting parcel.

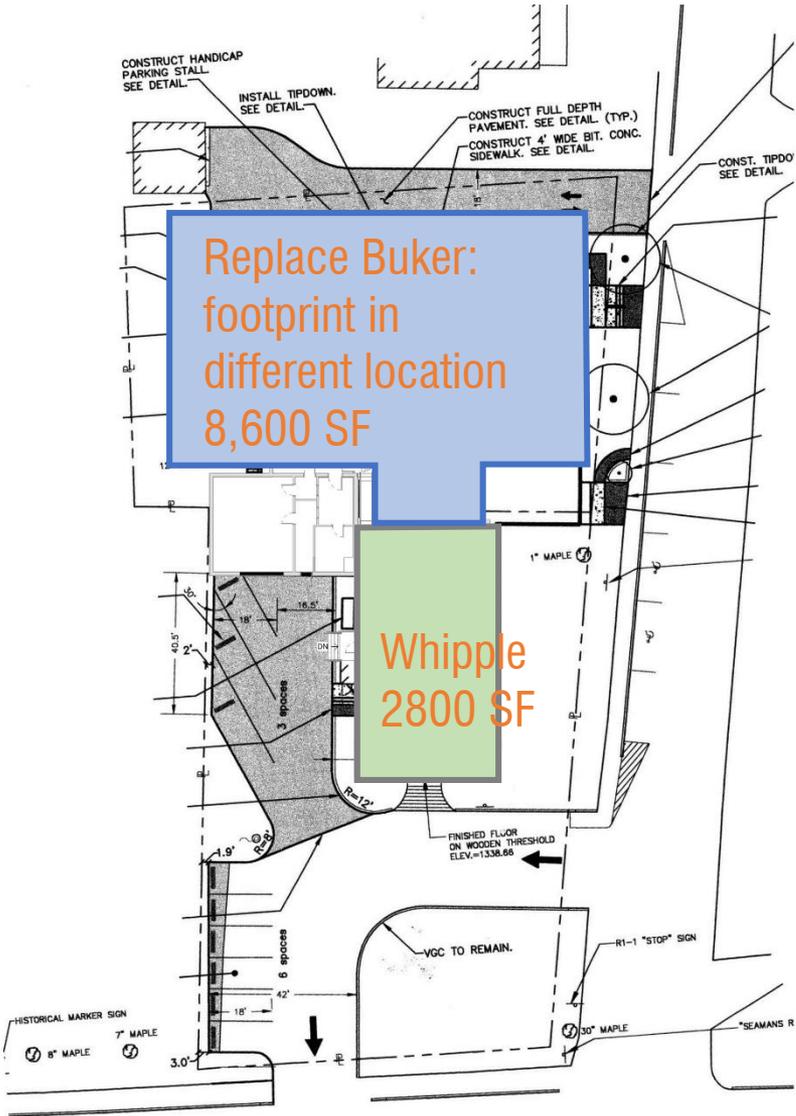
1 FIRST FLOOR PLAN
SCALE: 1/16" = 1'-0"

Preliminary Blocking Diagrams – Option 2

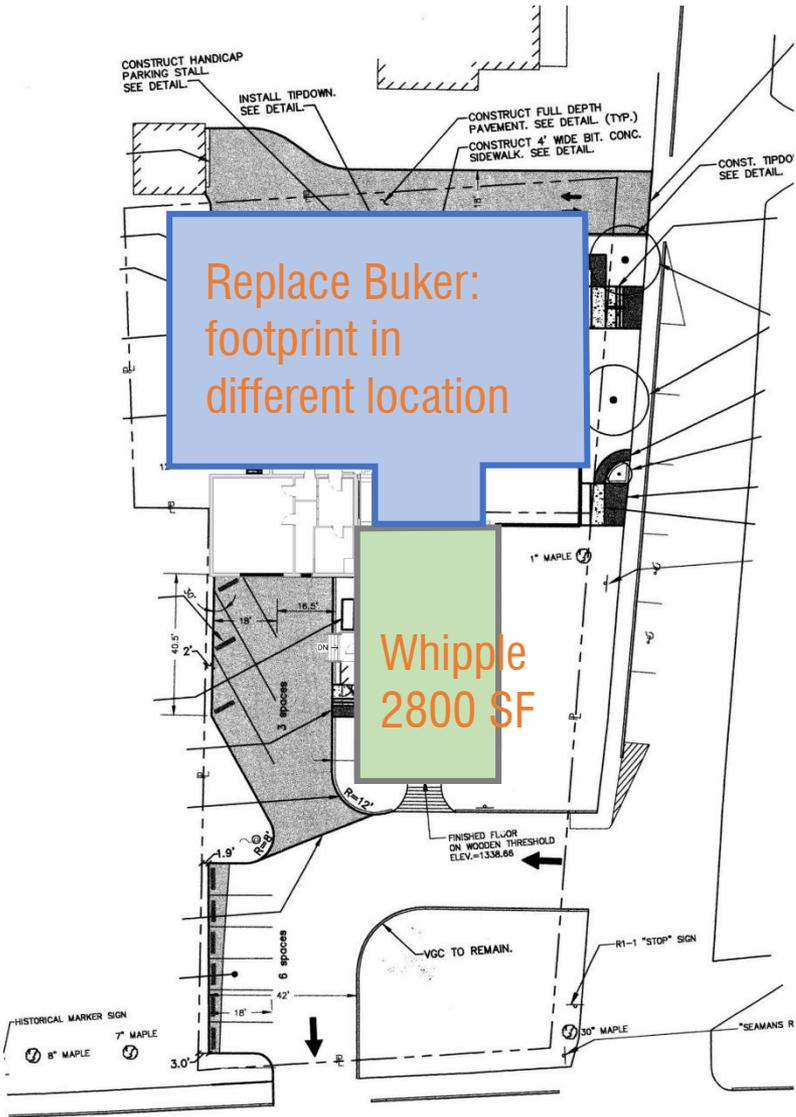
1 FIRST FLOOR PLAN
SCALE: 1/16" = 1'-0"

Preliminary Blocking Diagrams – Option 3

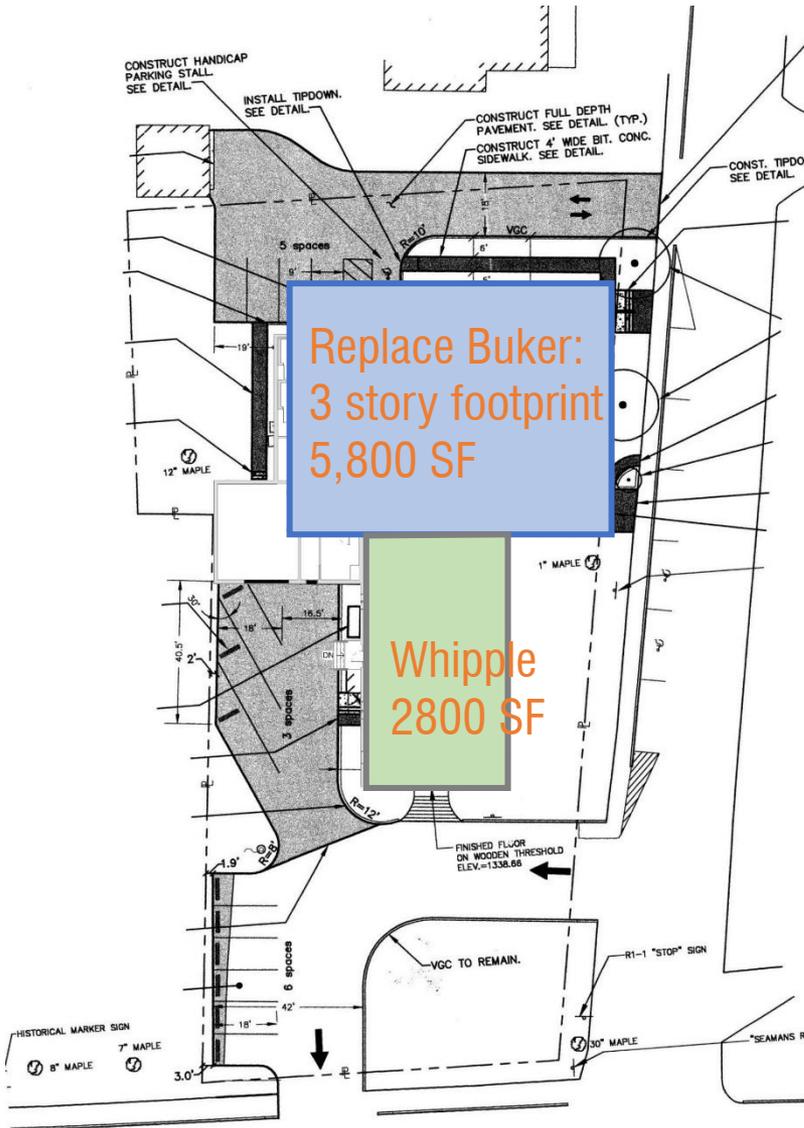
1 FIRST FLOOR PLAN
SCALE: 1/16" = 1'-0"

Preliminary Blocking Diagrams
